Hitchcock Road Site

2011 Annual Groundwater Management Plan

27 JULY 2011

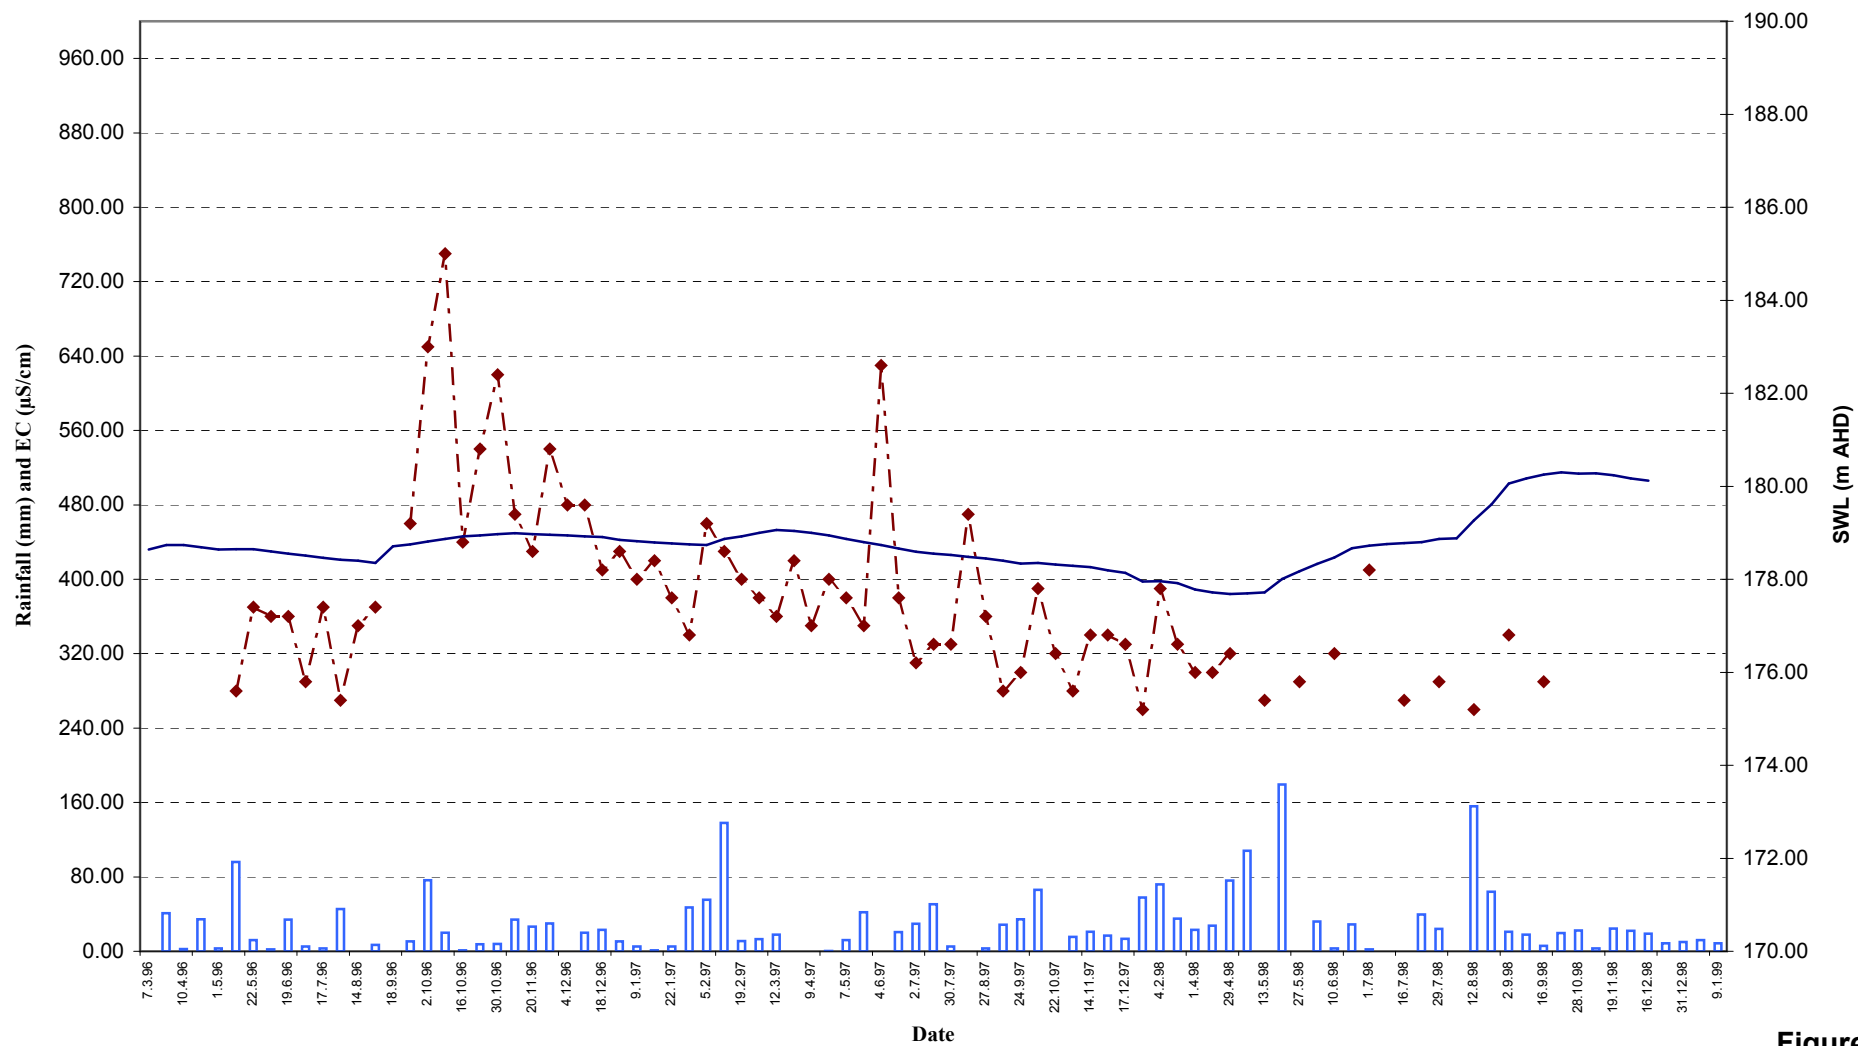
Figure 2

P.F.FORMATION
Bore PF167MW1 Groundwater Monitoring Data

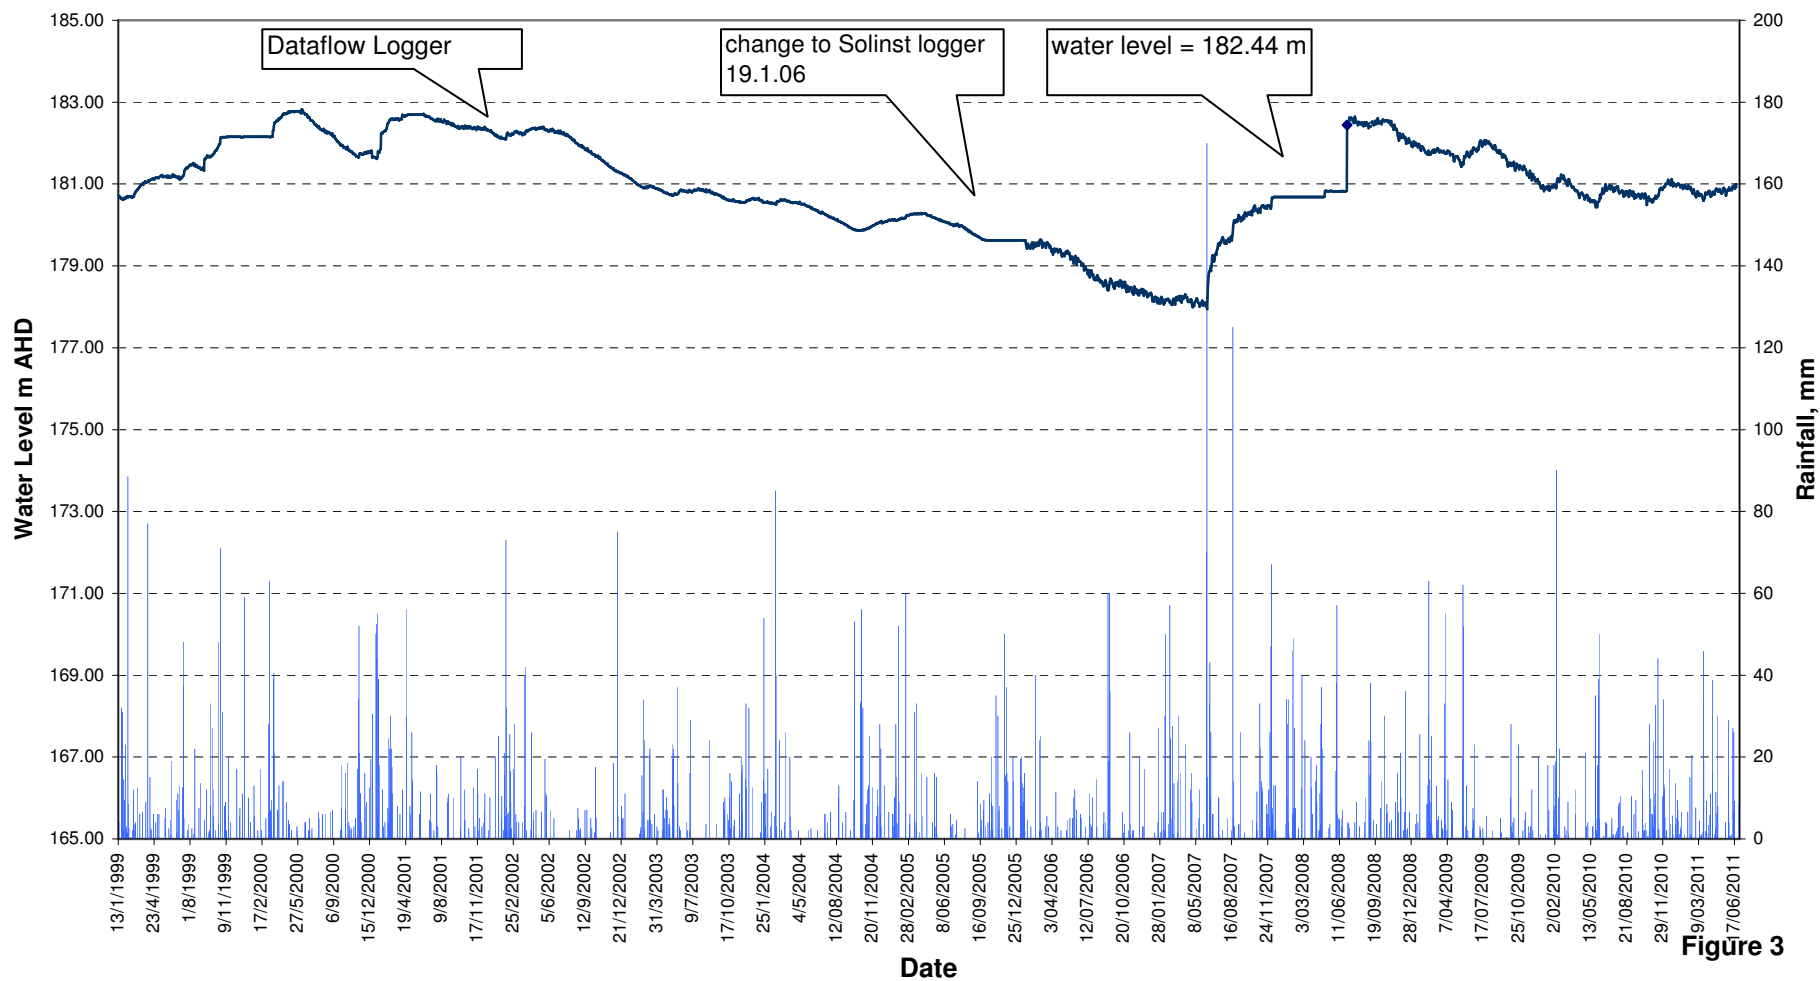
Figure 3

PF FORMATION
Bore PF167MW1 Groundwater Monitoring Data

□ Rainfall, mm
— Water level m AHD

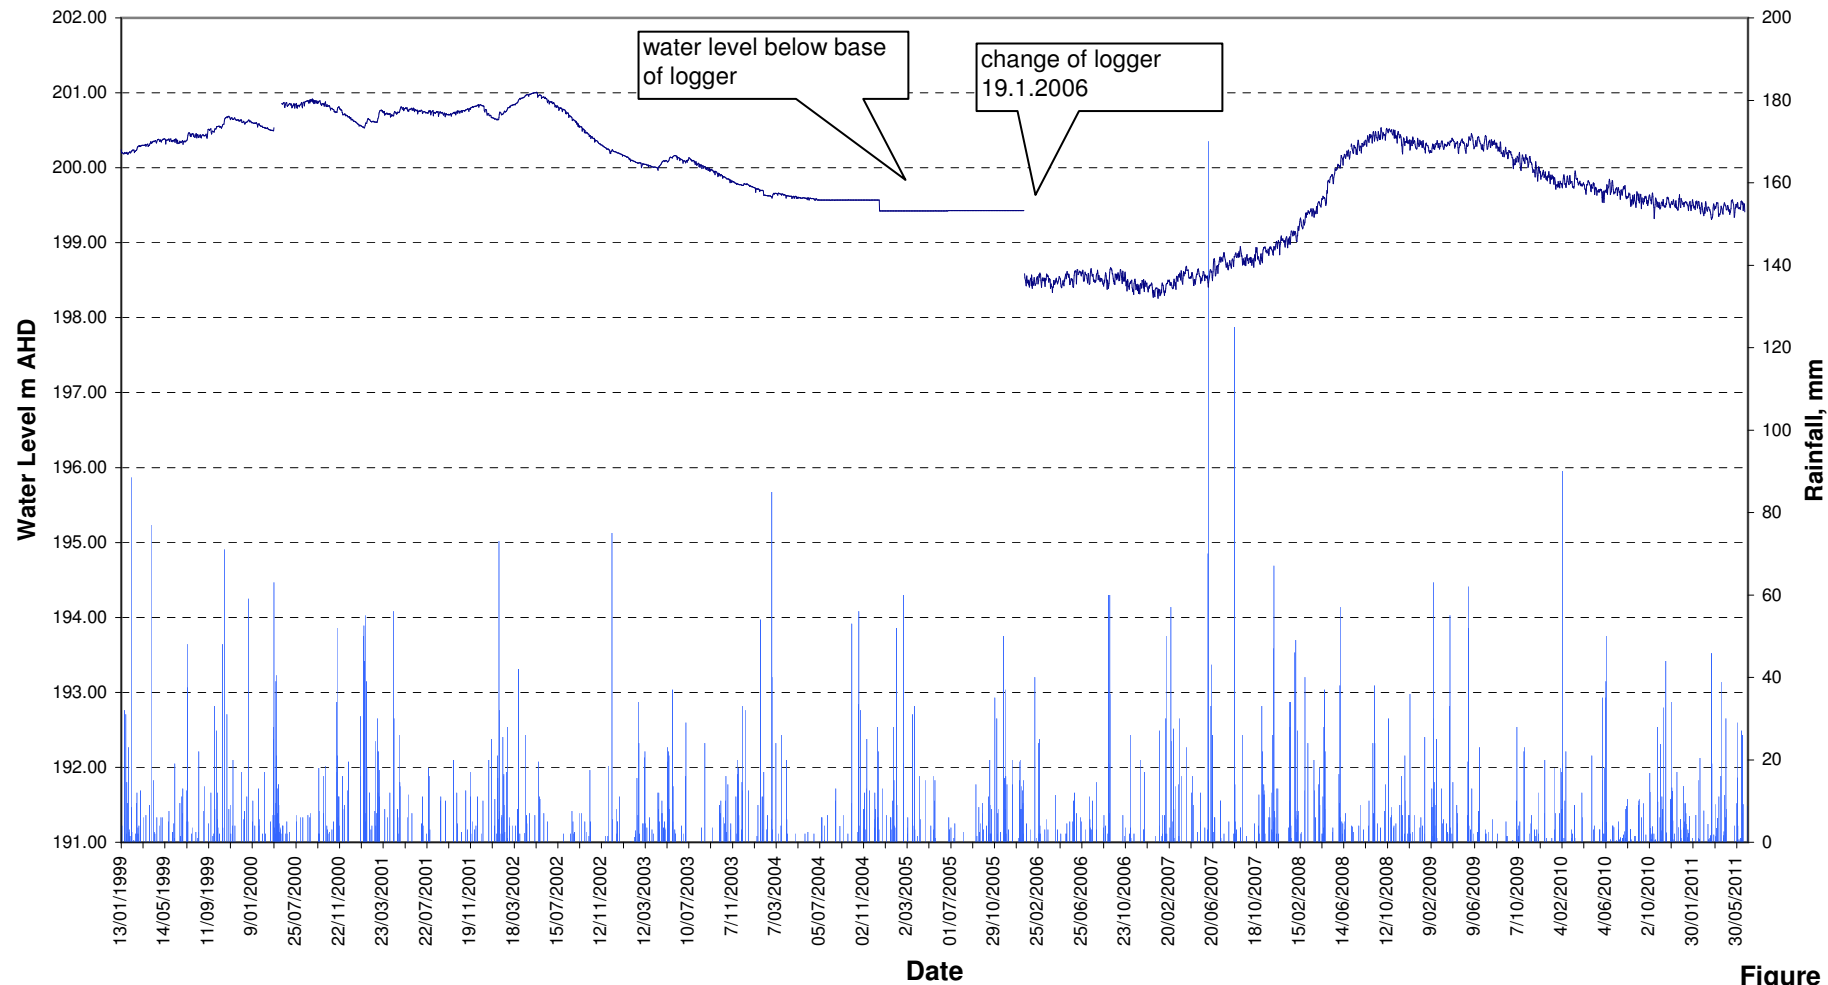
Figure 5

PF FORMATION
Bore PF166MW1 Groundwater Monitoring Data

□ Rainfall, mm
— Water Level m AHD

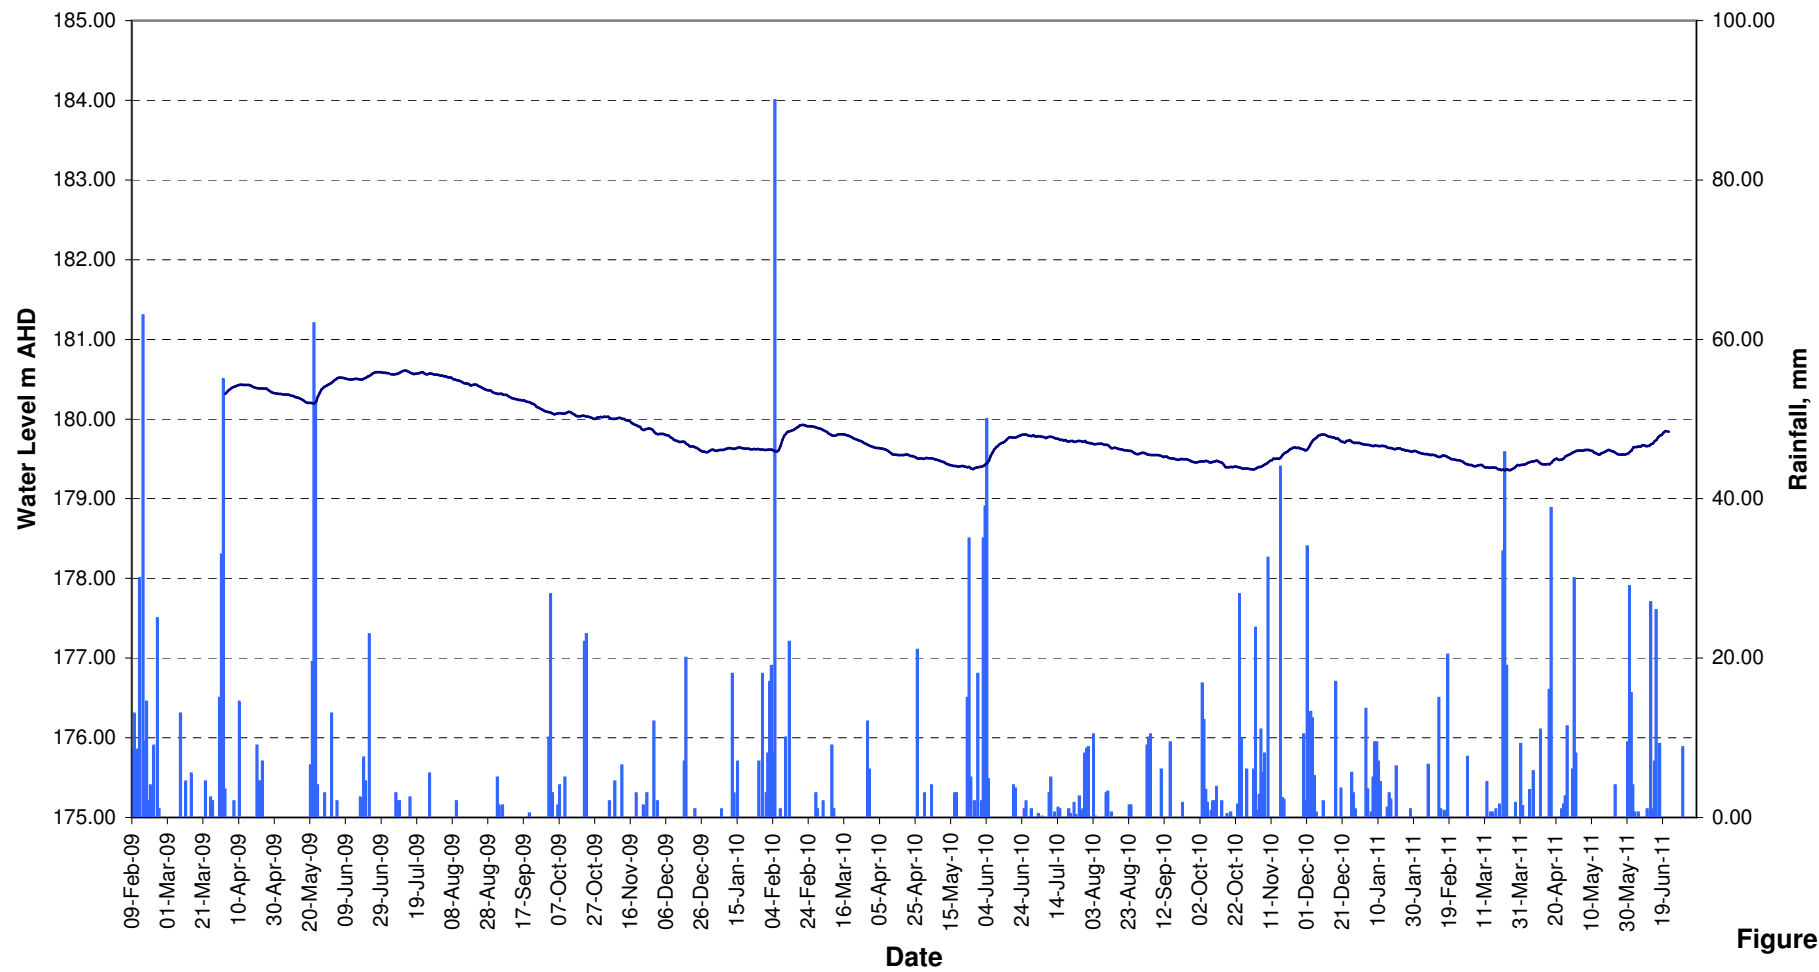
Figure 6

PF FORMATION
Bore PFP214MW1 Groundwater Monitoring Data

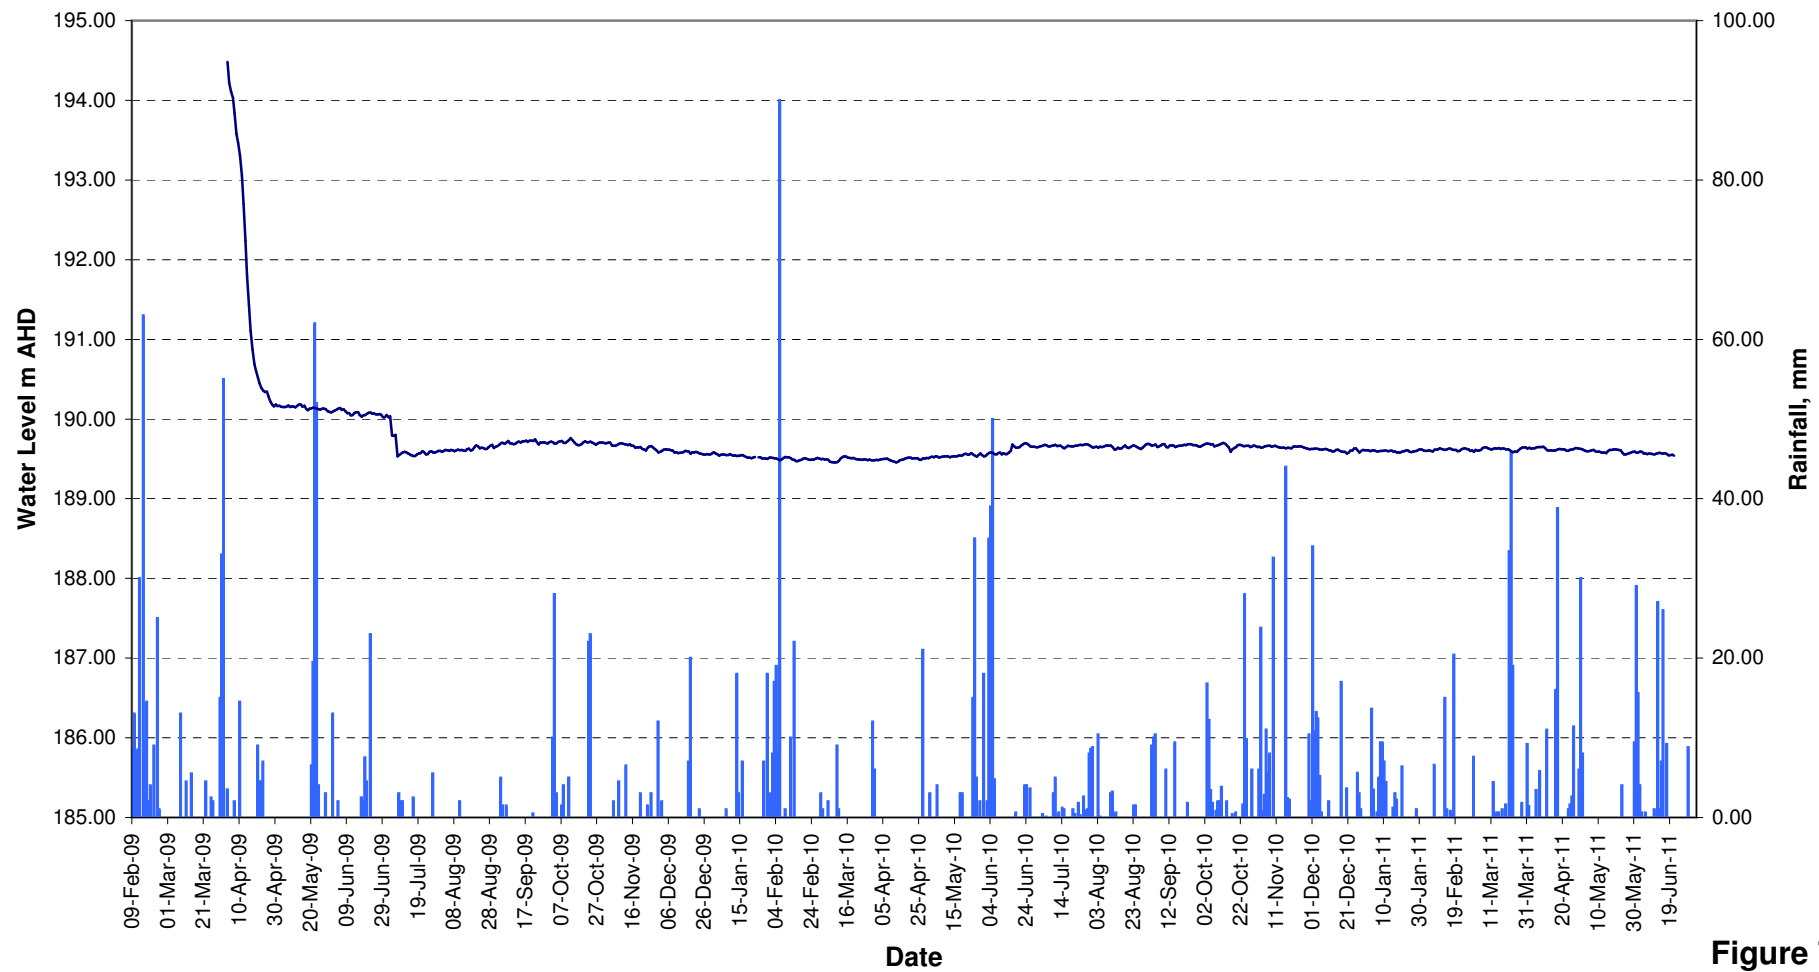
Figure 7

PF FORMATION
Bore PFL2HitchMW1 Groundwater Monitoring Data

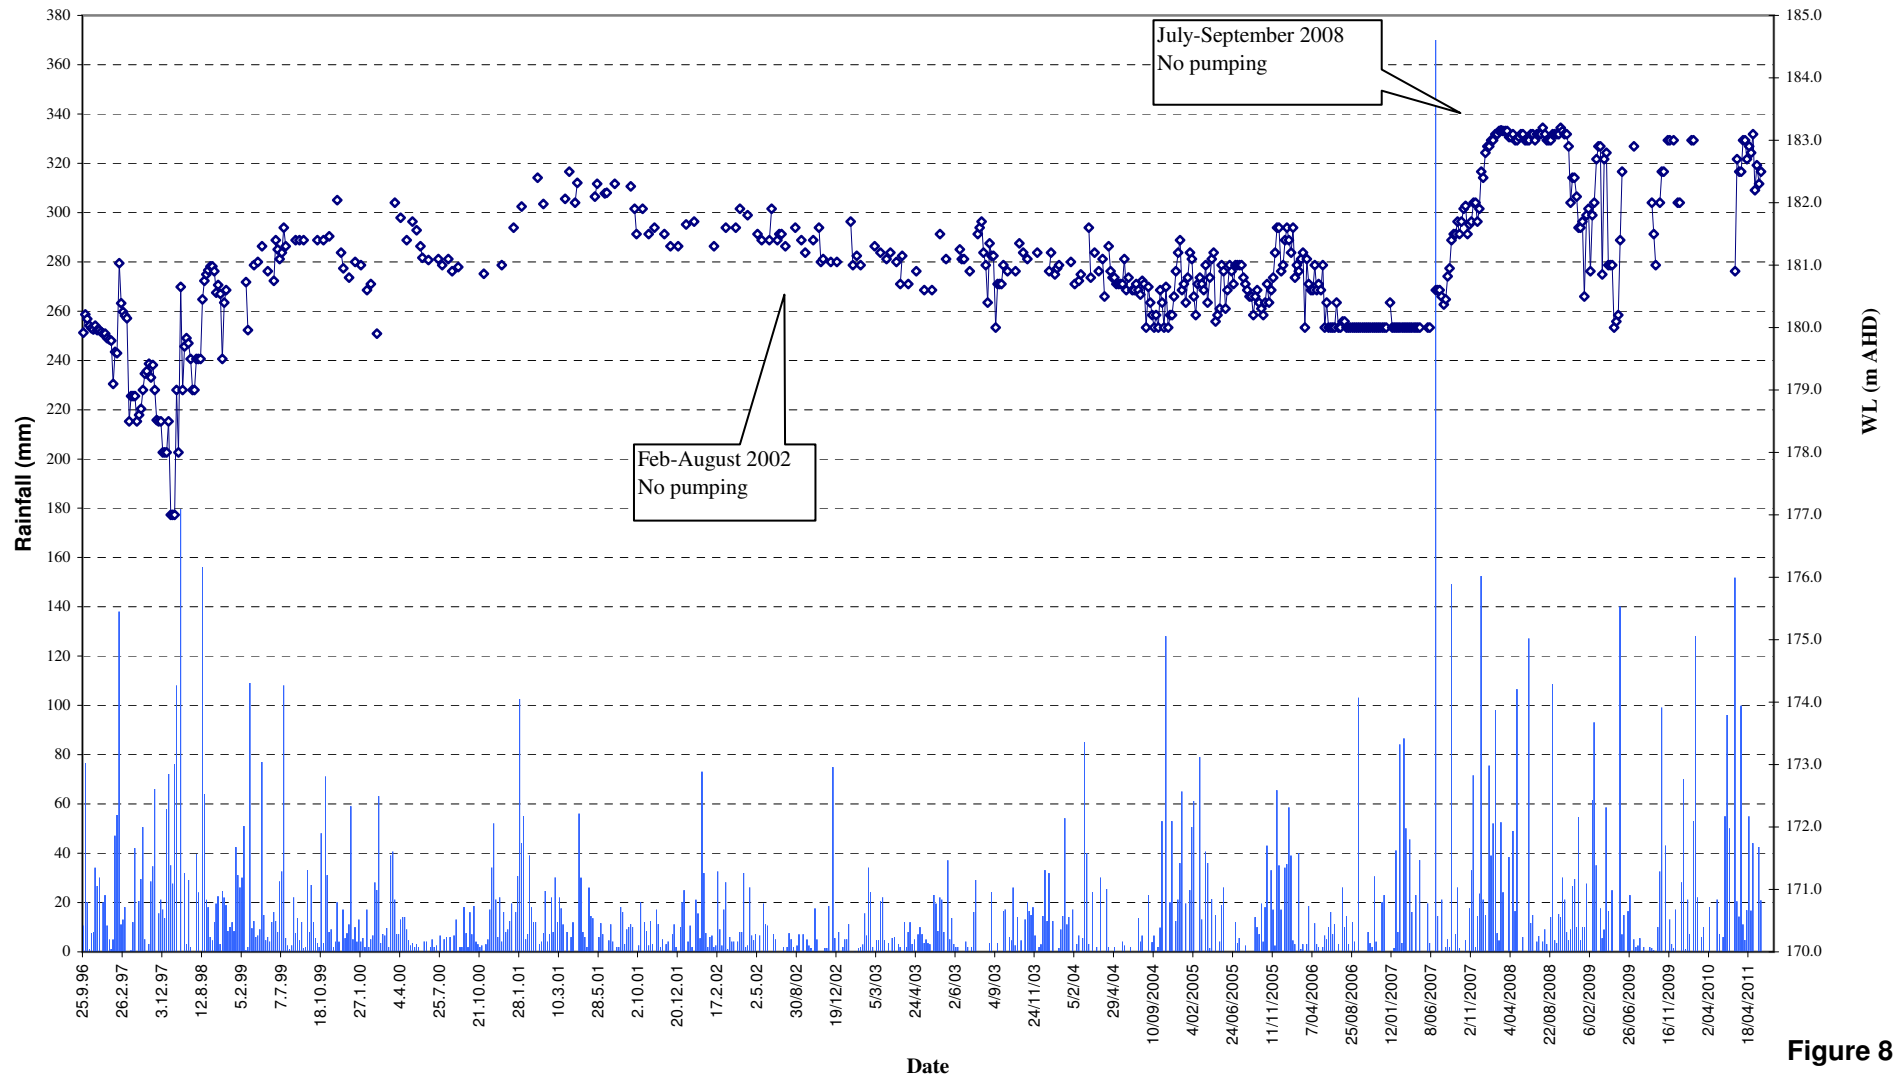
PF FORMATION
PF167DAM, Licence No. 10BL157308, Groundwater Monitoring Data

— Rainfall mm, since last reading
— WL m AHD

Although water is pumped from the dam for a variety of purposes, such as dust suppression and irrigation of rehabilitated areas and, more recently, for sand slurring, records show that water levels return rapidly to the average values indicated above, even after higher levels are experienced after heavy rainfall and consequent run-off. Figure 8 shows these combined effects upon the water level in the dam. The records suggest that the Maroota Sand aquifer at the site is capable of sustaining the required pumpage even under the low rainfall recharge conditions and the additional demand posed upon it in the wider Maroota area by the many groundwater users.

- records indicate that the water level in the dam recovers rapidly upon cessation of pumping.
- groundwater pumpage from the deep water supply bores in Portion 198 (11.8 ML) has been effected only from bore PF198PB1, as the second production bore PF198PB2 has been out of operation since December 2009. The pump in this bore has been replaced in July 2011.

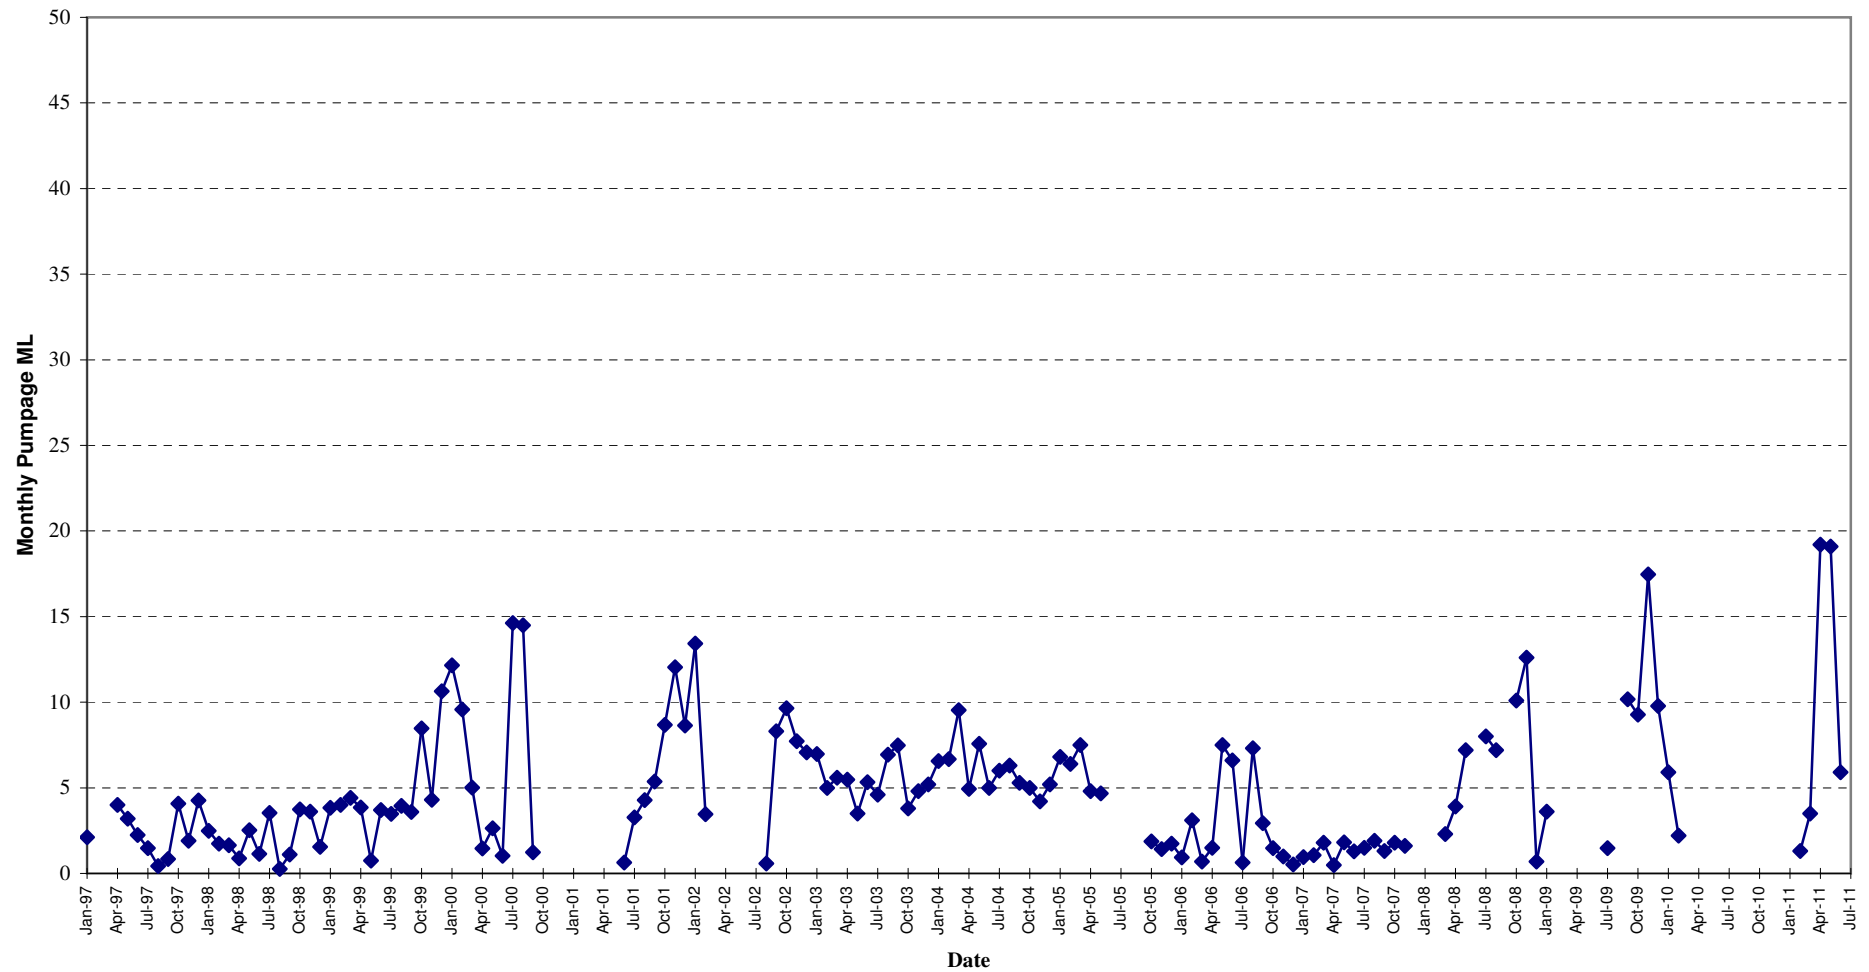
Figure 9

PF FORMATION
PF167DAM Monthly Pumpage Records

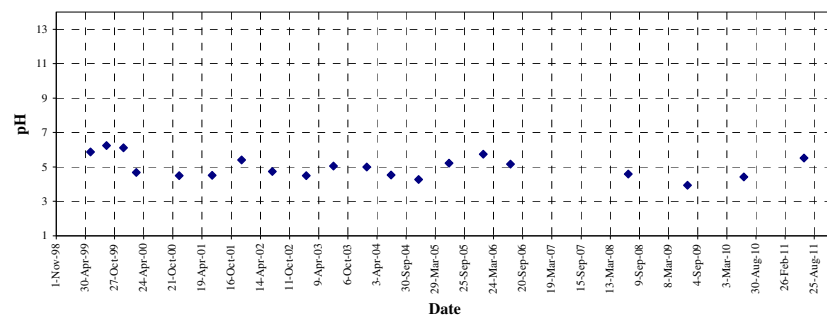
PF FORMATION Bore PF198PB1 - pH

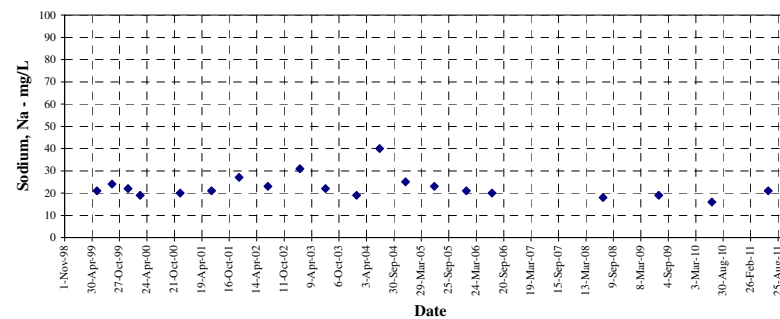
PF FORMATION Bore PF198PB1 - Sodium

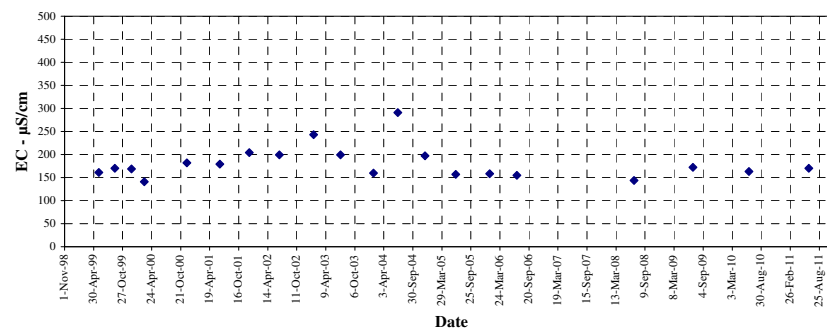
PF FORMATION Bore PF198PB1 - Electrical Conductivity

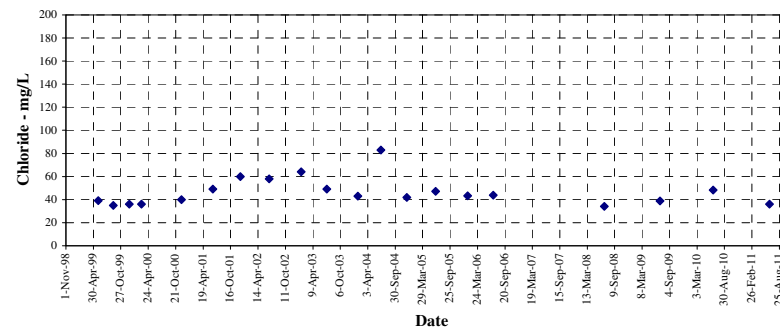
PF FORMATION Bore PF198PB1 - Chloride

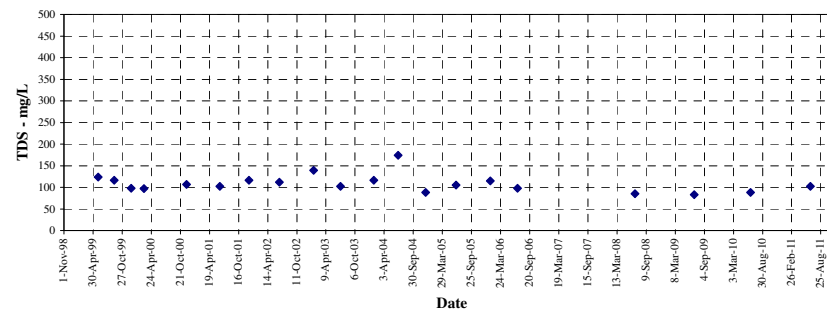
PF FORMATION Bore PF198PB1 - Total Dissolved Solids

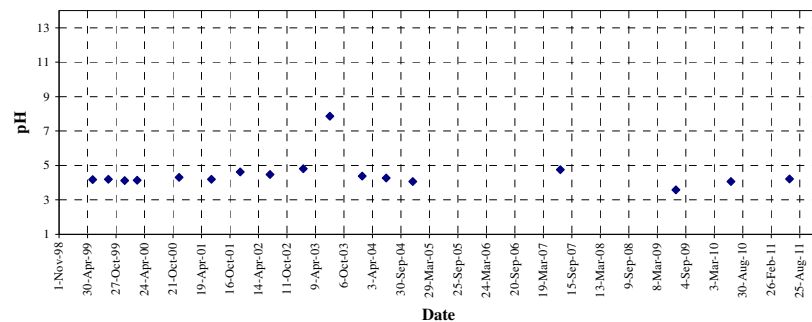
PF FORMATION - Bore PF166MW1 - pH

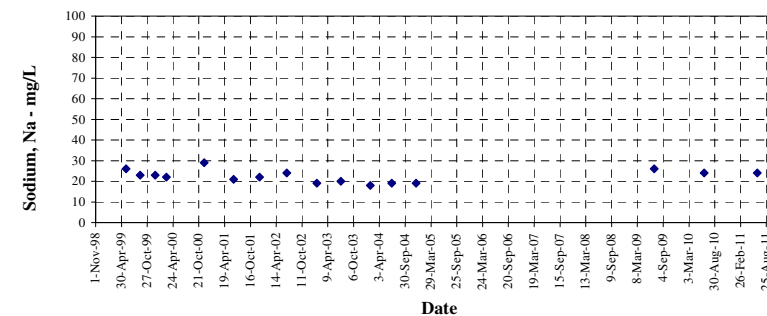
PF FORMATION - Bore PF166MW1 - Sodium

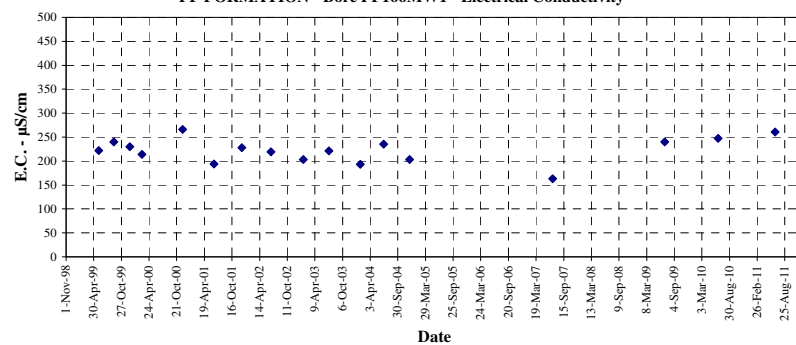
PF FORMATION - Bore PF166MW1 - Electrical Conductivity

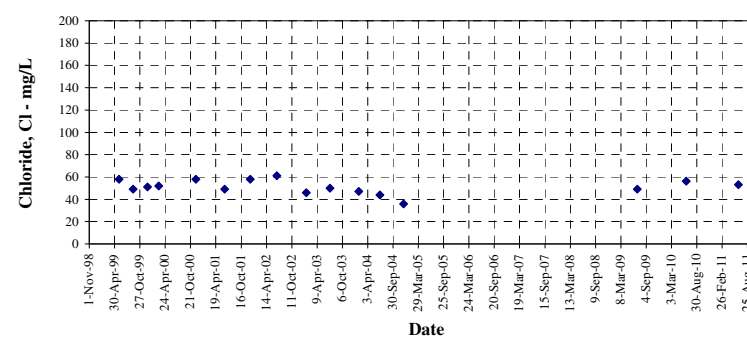
PF FORMATION - Bore PF166MW1 - Chloride

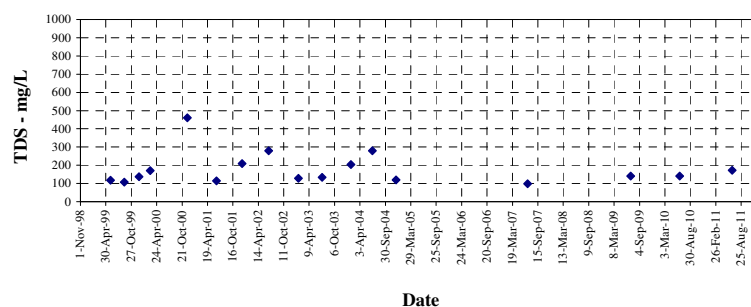
PF FORMATION - Bore PF166MW1 - Total Dissolved Solids
