## HITCHCOCK ROAD SAND EXTRACTION AND REHABILITATION PROJECT, MAROOTA

ANNUAL ENVIRONMENTAL MANAGEMENT REPORT

**2014 - 2015**

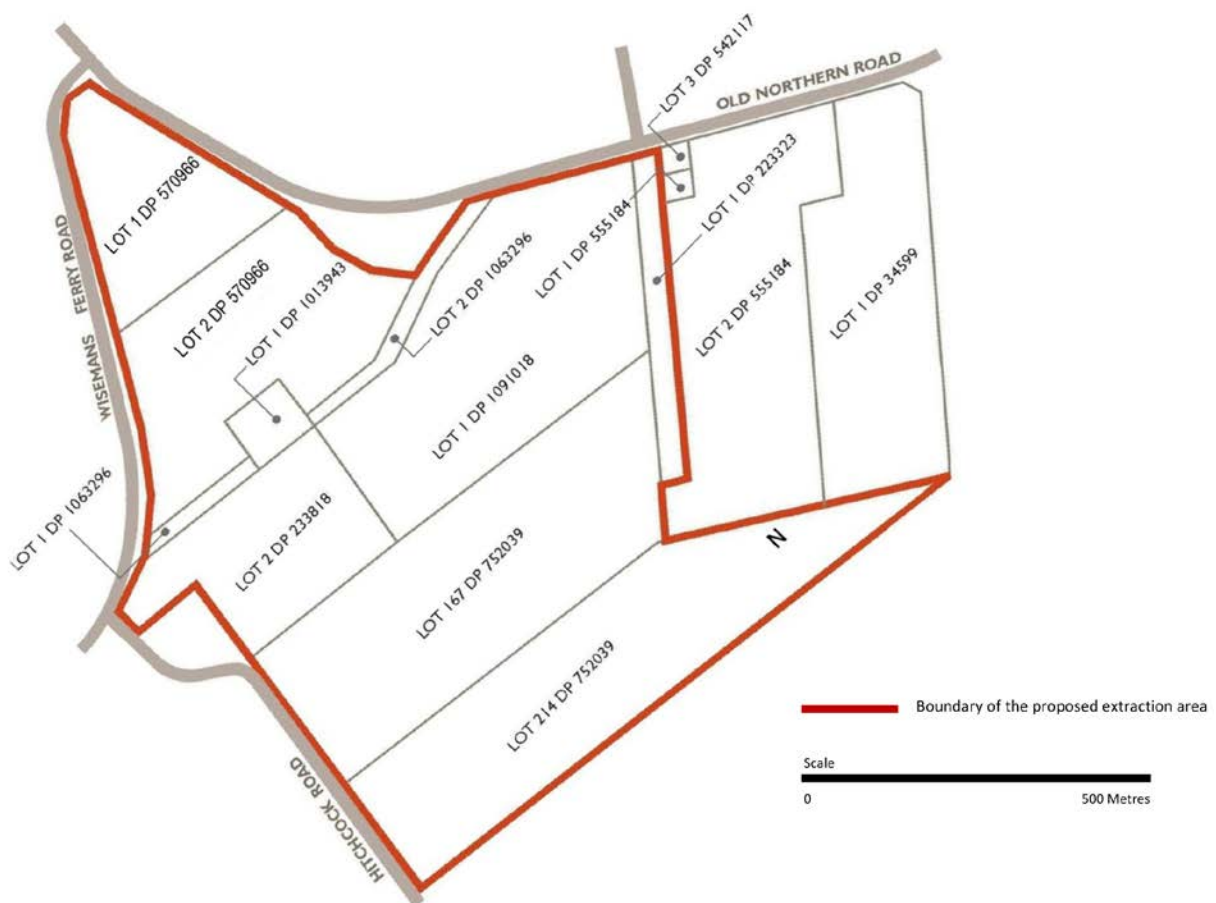
**Figure 1 Lots Included in the Extraction Area**

The location and legal description of the various lots that make up the extraction area of the site is shown in **Figure 1**.

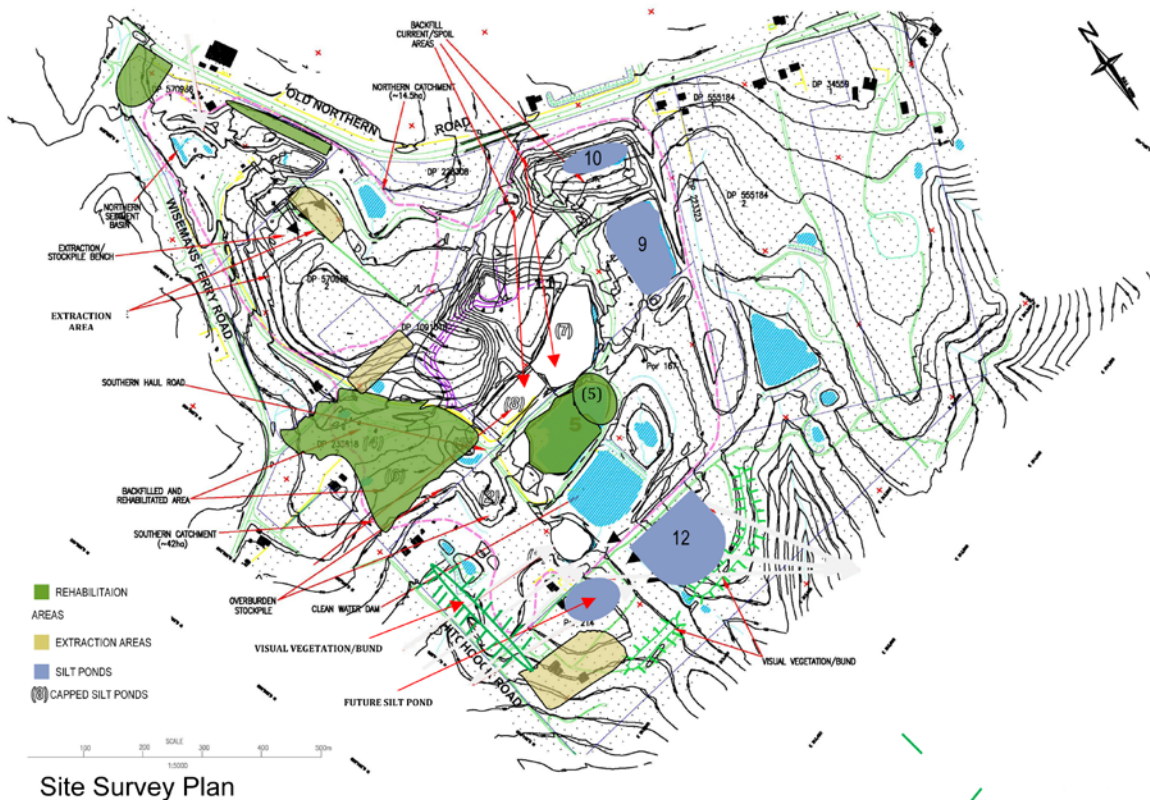
Figure 2 Site Survey Plan

The site survey plan in **Figure 2** over shows the current status of the development including works carried out in the last 12 months. Photographs of development works are included in **Attachment 1**.

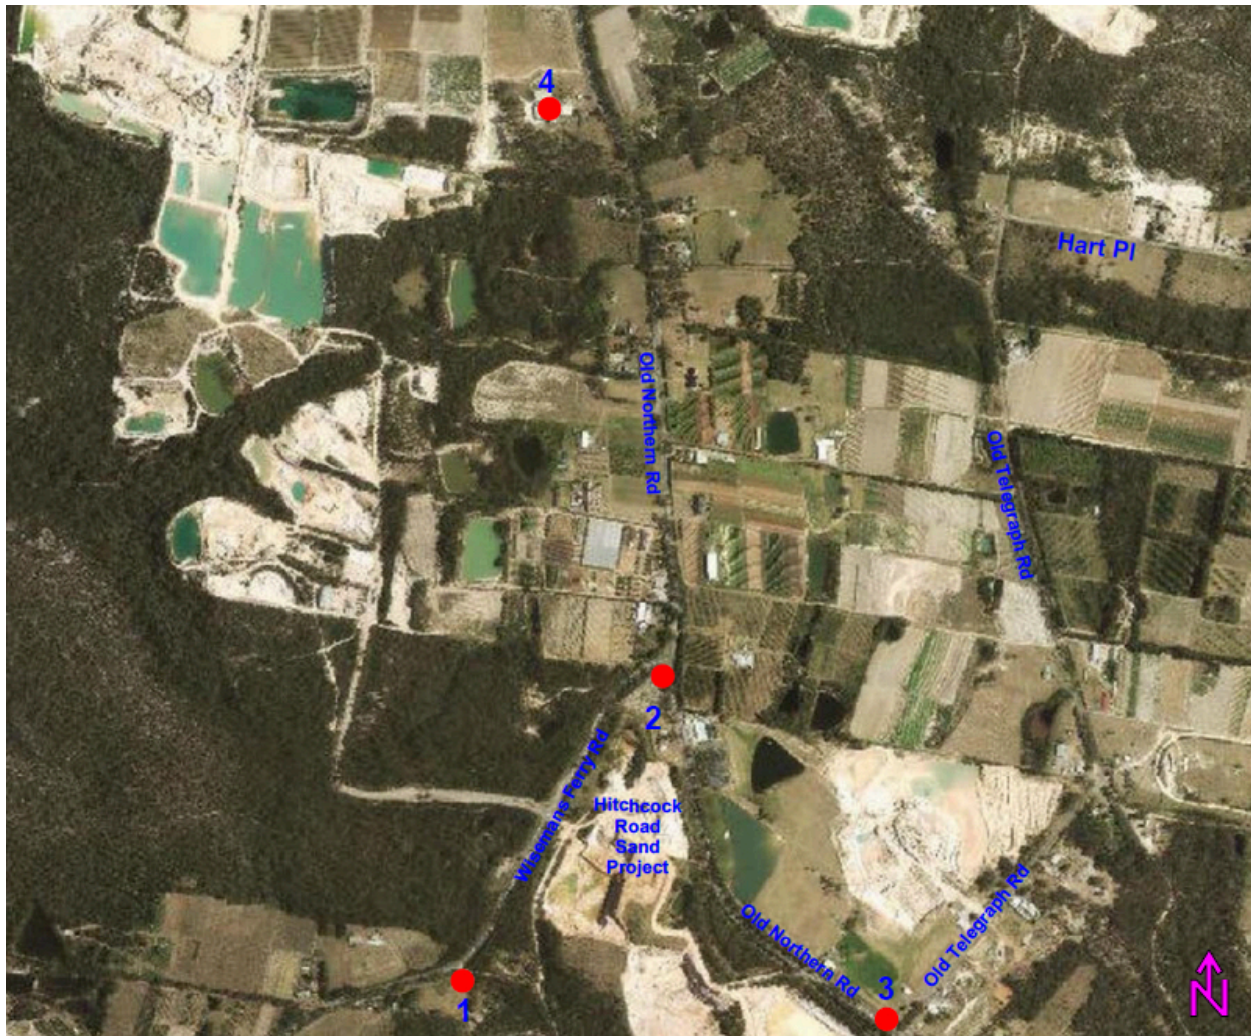
**Figure 3 Noise Impact Assessment Monitoring Locations**

The Noise Management Plan requires the noise criteria set out in **Table 2** to be applied to the impact assessment. These assessment locations as shown on **Figure 3** over, were selected because they are representative or closer to the quarry than the Noise Assessment Locations identified in Table 1 of Schedule 3 to the Notice of Project Approval.

The locations used by Koikas Acoustics correspond to the locations in **Figure 3**.

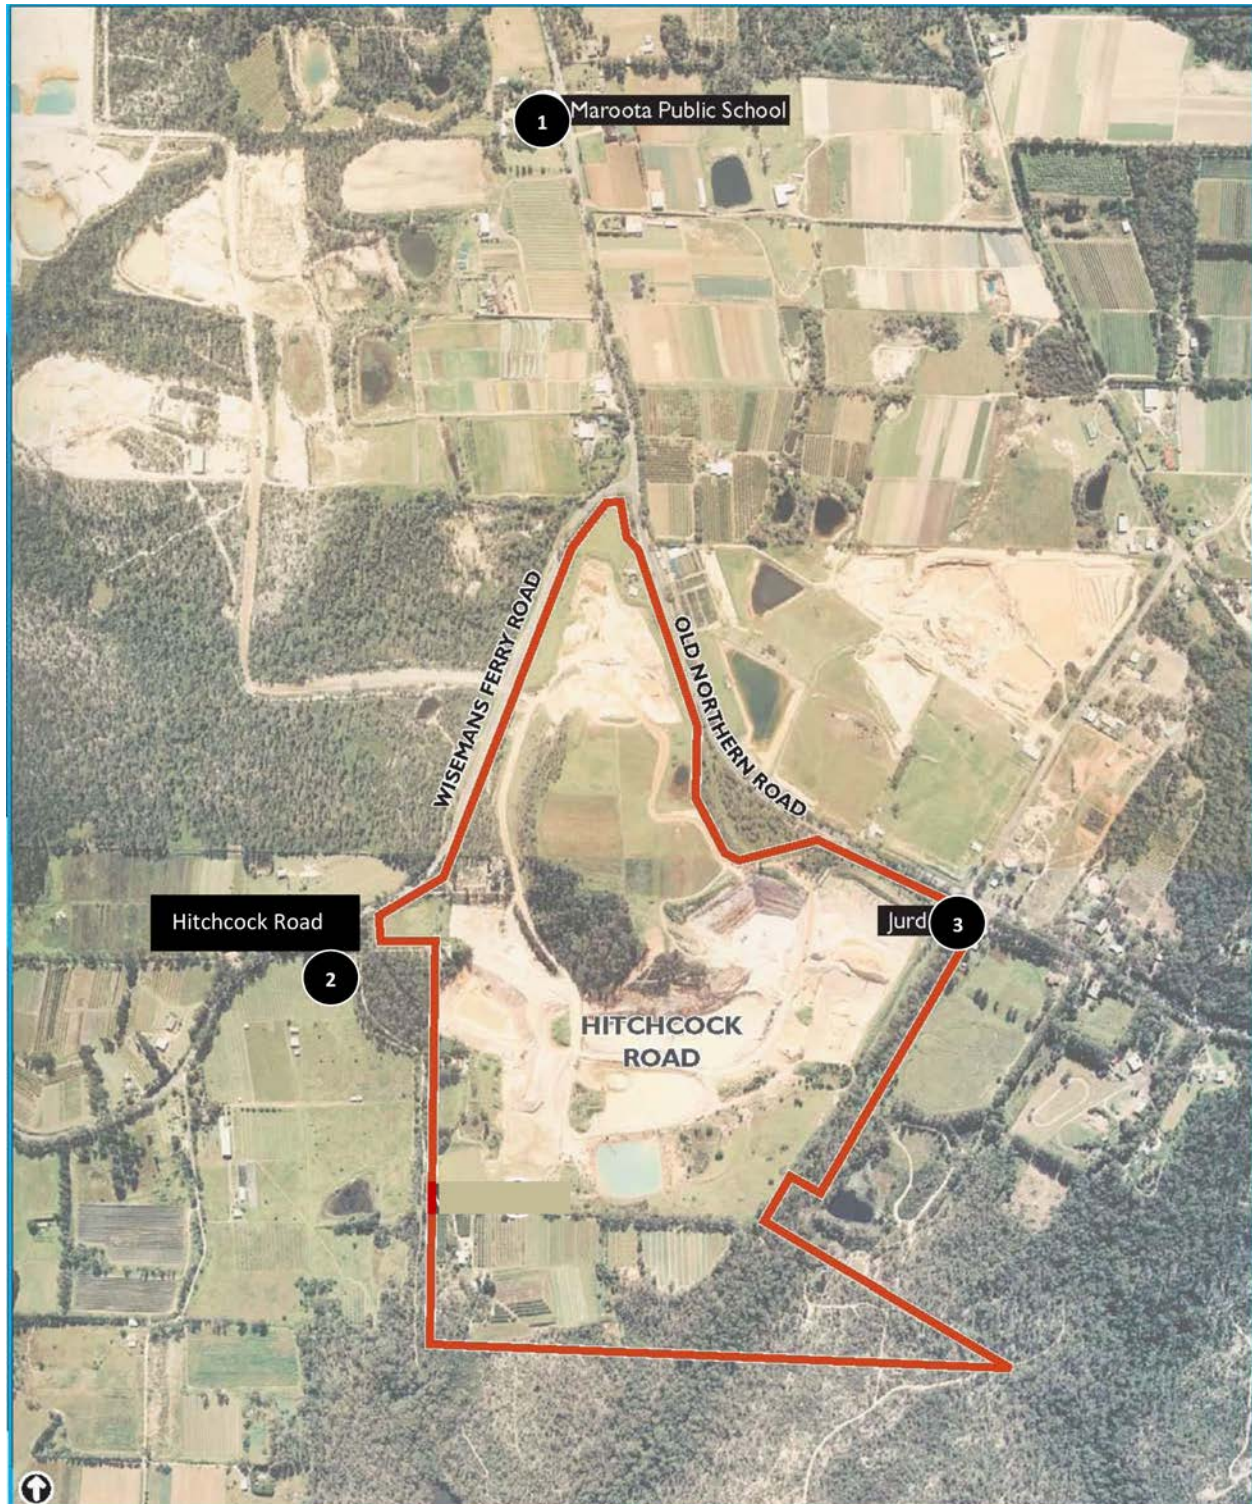
**Figure 4 Dust Deposition Monitoring Locations**

PF Formation has maintained a program of continuous monthly dust deposition monitoring. This is in compliance with the requirements of the Air Quality Monitoring Program. The locations of the monitoring stations are shown on **Figure 4**.

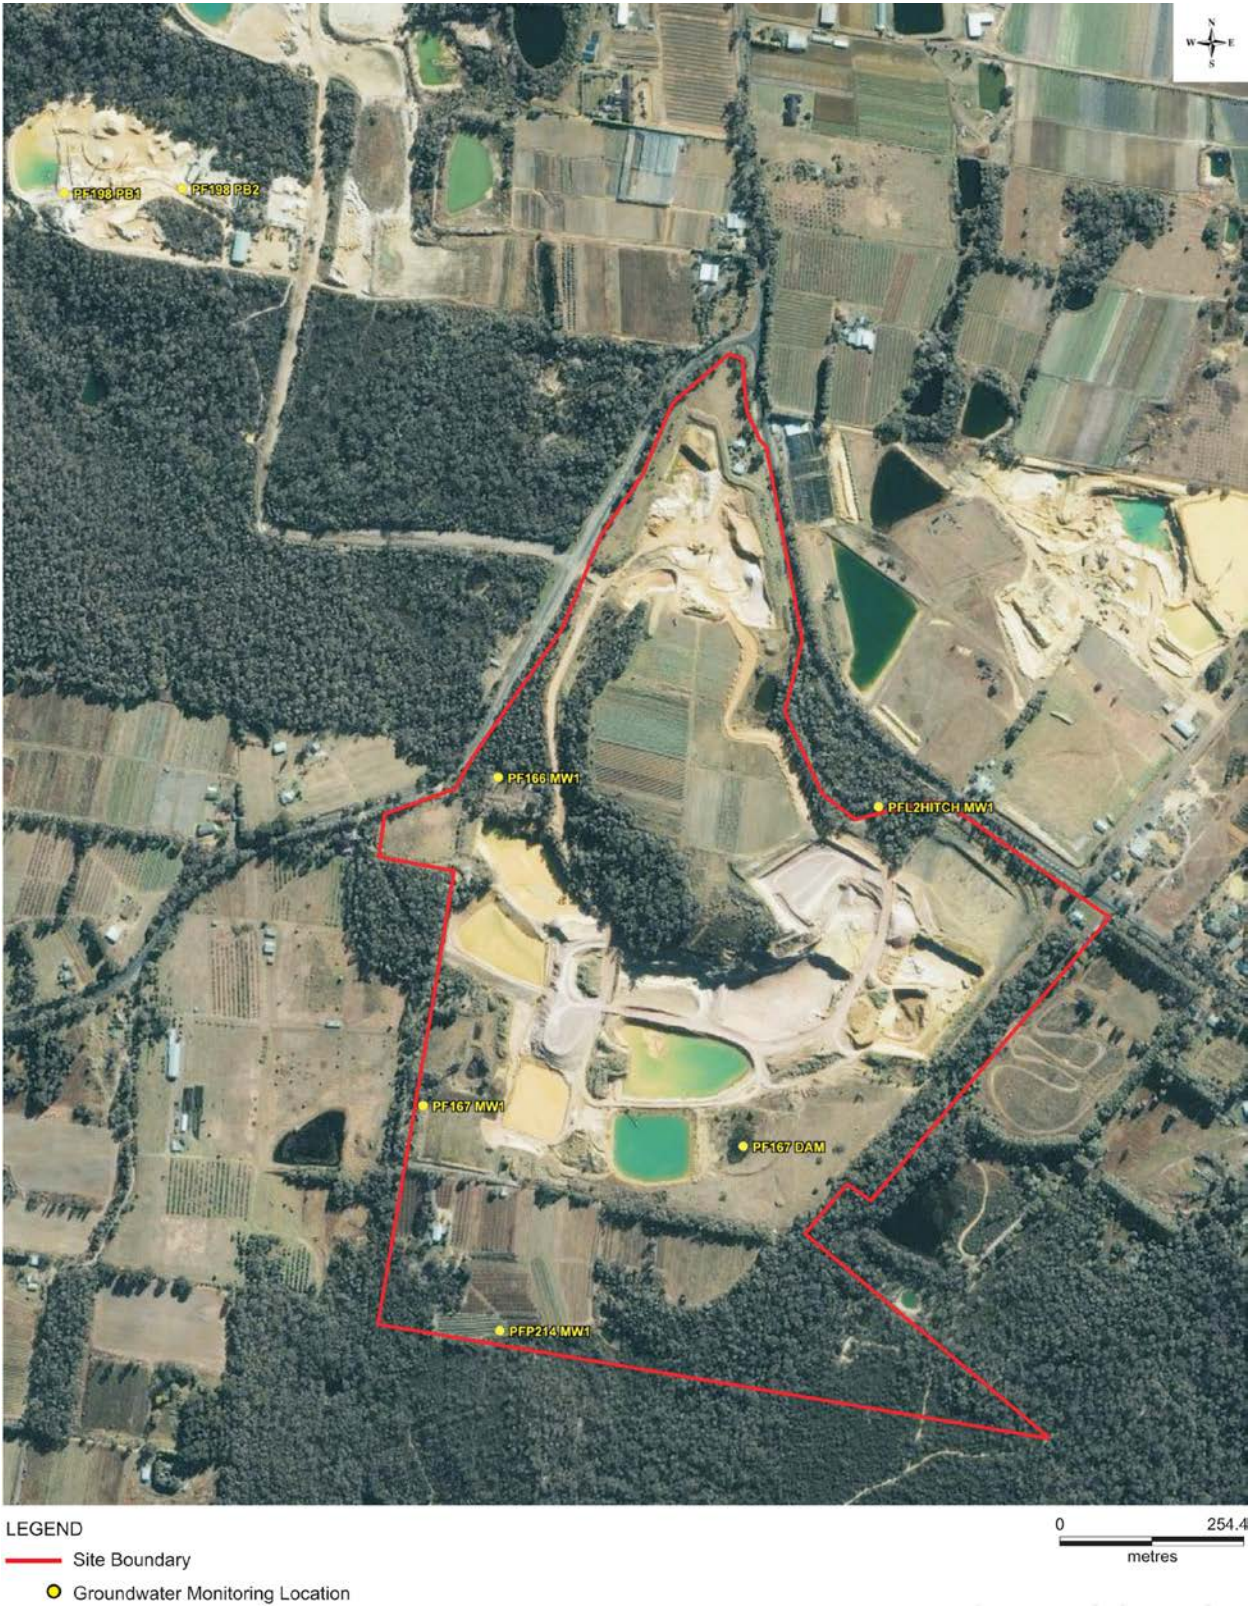
Figure 5 Groundwater Monitoring Locations

In addition, groundwater pumpage and chemical records are also collected from one of the two water supply bores in Portion 198 (i.e. PF198PB1). Groundwater monitoring has been carried out at the sites since 1996.
