# HITCHCOCK ROAD SAND EXTRACTION AND REHABILITATION PROJECT, MARROTA

ANNUAL ENVIRONMENTAL MANAGEMENT REVIEW  
**2019 - 2020**

### Sand Extraction and Rehabilitation Project

# ANNUAL ENVIRONMENTAL MANAGEMENT REVIEW 2019-2020

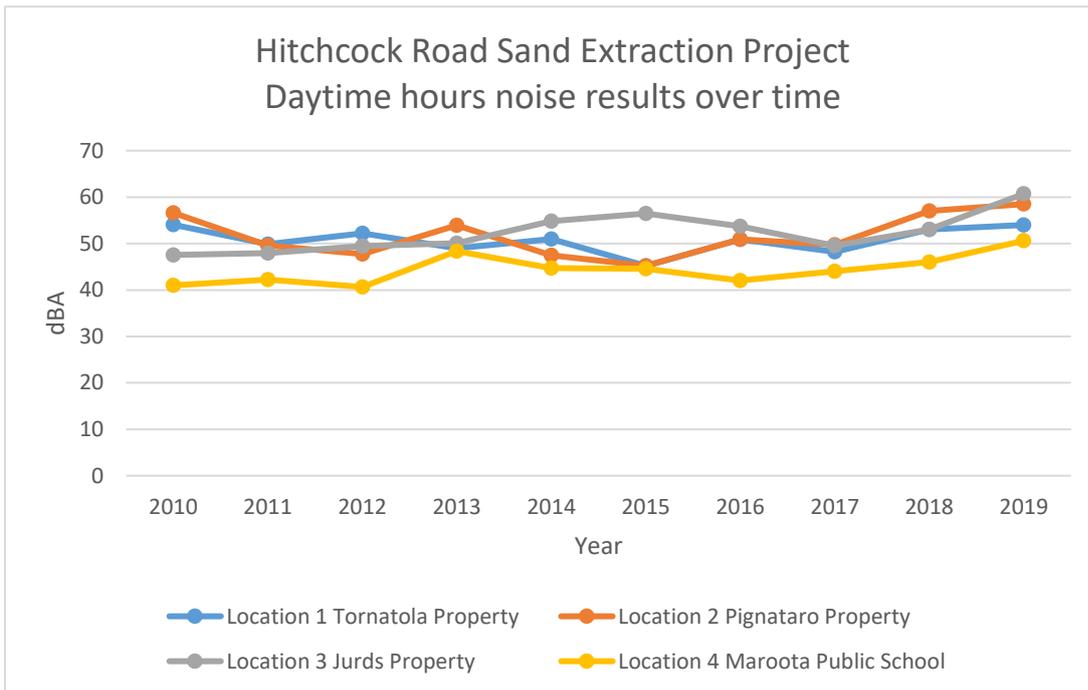
**Chart 1.** Daytime noise result trends over time

Koikas Acoustics concluded that noise results at all sites had been dominated by traffic or environmental noises during acoustic surveys over the past 12 month period and that quarry noise was either barely audible or inaudible. The site therefore complies with the nominated noise criteria.

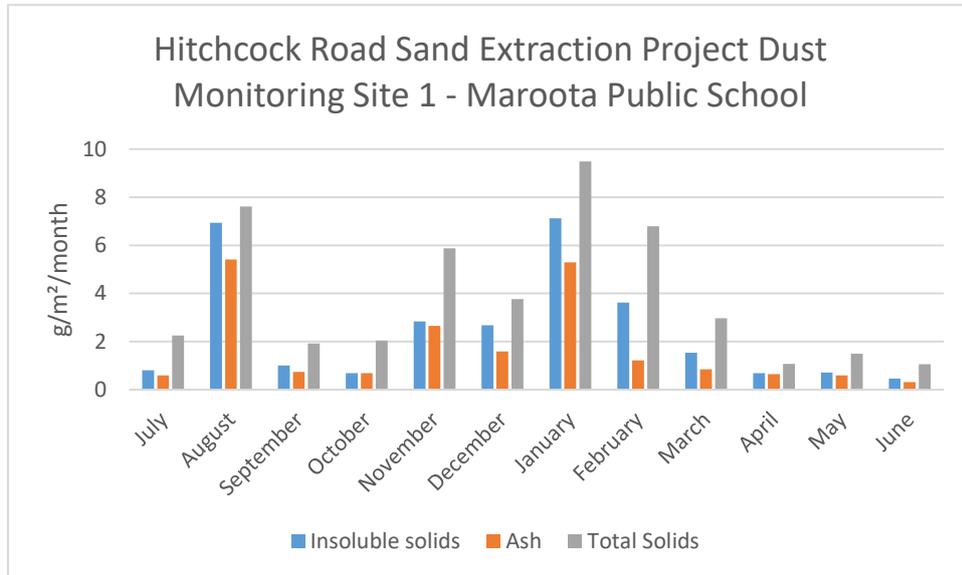
**Chart 3.** Dust monitoring results at Site 1 – Maroota Public School

- The spike in August is related to the Maroota Muster event held annually at the Maroota Public School. Dry conditions with slashing/mowing of the adjacent paddock for heavy traffic flow on the day of the event almost always leads to a spike in total solids each reporting period.

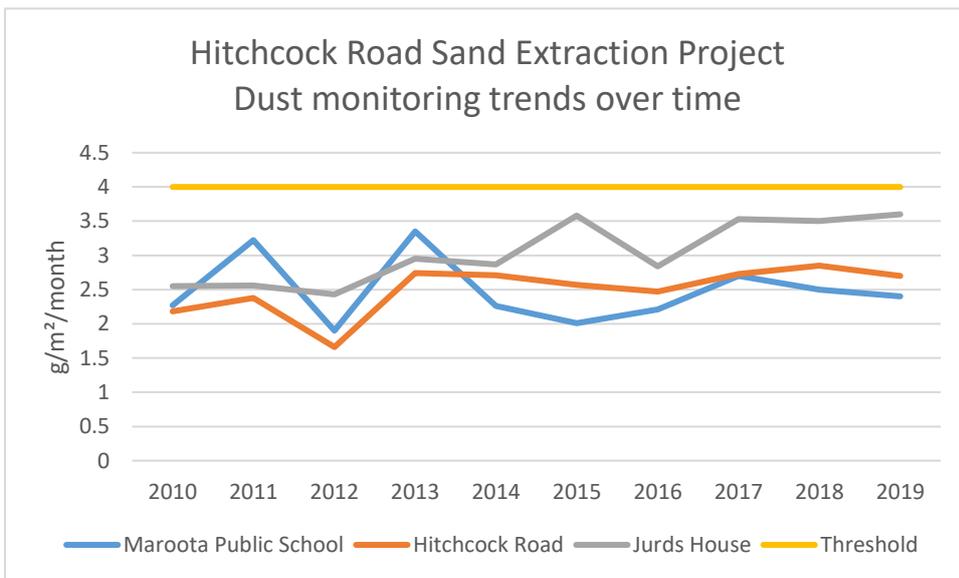
**Chart 6.** Dust monitoring trends over time – Insoluble Solids

- The insoluble solids portion of deposited dust is expected to be mineral matter with the ash content indicating the level of solid dust particles of inorganic origin such as soil/dust that could be derived from a source such as sand extraction and processing operations.
- The monitoring results are characterised by generally low average levels over extended periods with an occasional spike when high levels are experienced. As the operations from the site are

very consistent, the dust generated from the site is consistent subject to weather impacts. Spikes are usually caused by factors unrelated to the quarry such as mowing or horticultural activities near the monitoring station or regional issues such as bush fires and dust storms.

- During the summer months of the reporting period several dust storms were recorded by the Bureau Of Meteorology within the Sydney region which were a result of the drought conditions in Western NSW and strong westerly winds.

- The annual average ambient dust deposition rate (insoluble solids) considered a nuisance criterion is  $4 \text{ g/m}^2/\text{month}$ . All sites monitored had annual averages below this level despite the spikes caused by bushfires and dust storms. Location 1 – Maroota School average was  $2.4 \text{ g/m}^2/\text{month}$ , Location 2 – Hitchcock Road average was  $2.7 \text{ g/m}^2/\text{month}$ , Location 3 – Jurd's House average was  $3.16 \text{ g/m}^2/\text{month}$ .

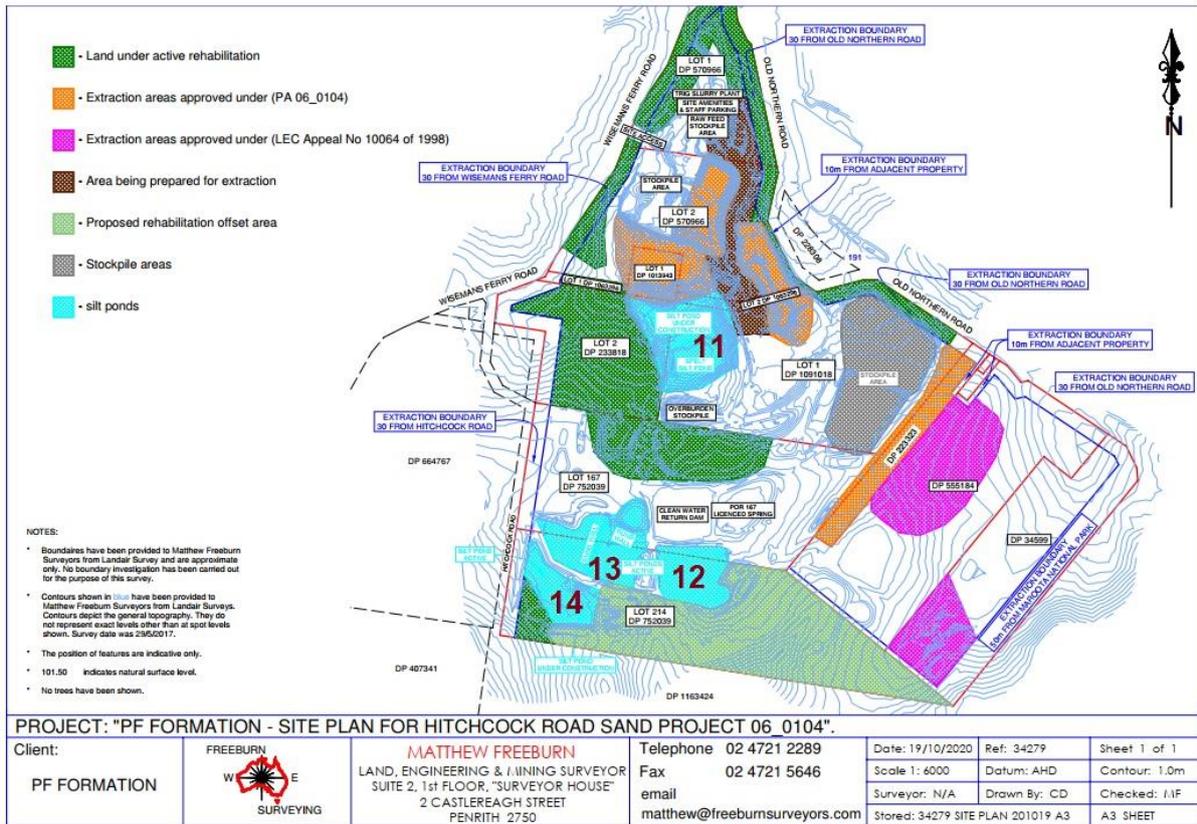
**Figure 5.** Location of numbered Silt ponds in tailings stream cycle.
