# HITCHCOCK ROAD SAND EXTRACTION AND REHABILITATION PROJECT, MAROOTA

ANNUAL ENVIRONMENTAL MANAGEMENT REPORT  
**2016 - 2017**

### Sand Extraction and Rehabilitation Project

# ANNUAL ENVIRONMENTAL MANAGEMENT REPORT 2016-2017

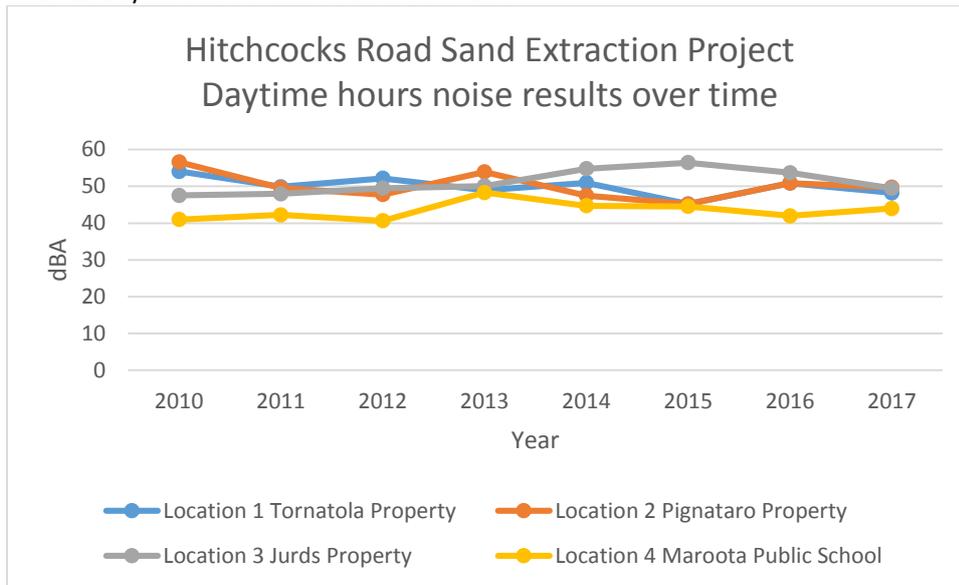
**Chart 1.** Daytime noise result trends over time

Koikas Acoustics concluded that at most sites the quarry noise was either just audible or inaudible. The site complies with the nominated noise criteria.

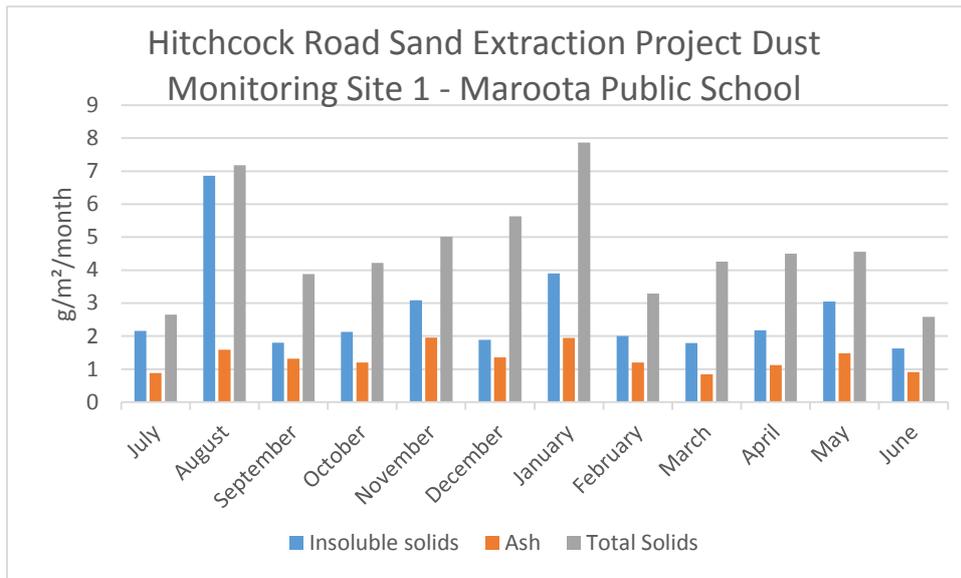
**Chart 3.** Dust monitoring results at Site 1 – Maroota Public School

- The annual average ambient dust deposition rate (insoluble solids) considered a nuisance criterion is 4 g/m<sup>2</sup>/month. All sites monitored had annual averages below this level. Location 1 – Maroota School average was 2.7 g/m<sup>2</sup>/month while Location 2 – Hitchcock Road was 2.73 g/m<sup>2</sup>/month.

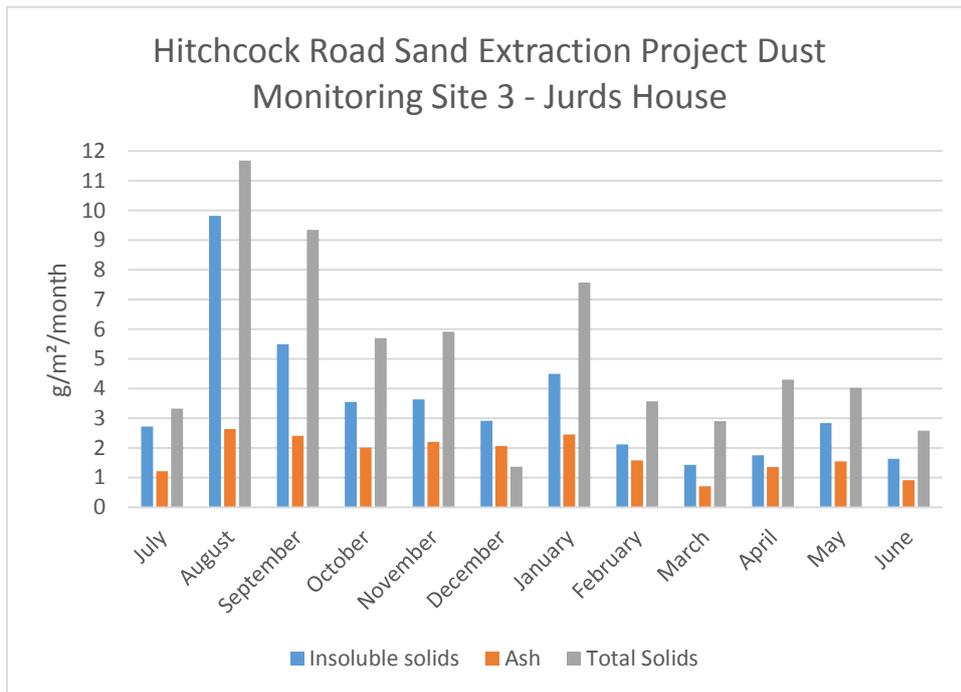
Chart 5. Dust monitoring results at Site 3 – Jurds House

- The annual average ambient dust deposit rate (insoluble solids) at Location 3 – Jurd’s House was 3.53 g/m<sup>2</sup>/month (2.87 in 2014). This is less than the dust nuisance criterion of 4 g/m<sup>2</sup>/month but higher than it has been in past years. August experienced a spike in levels which may have been attributed to dry windy weather.

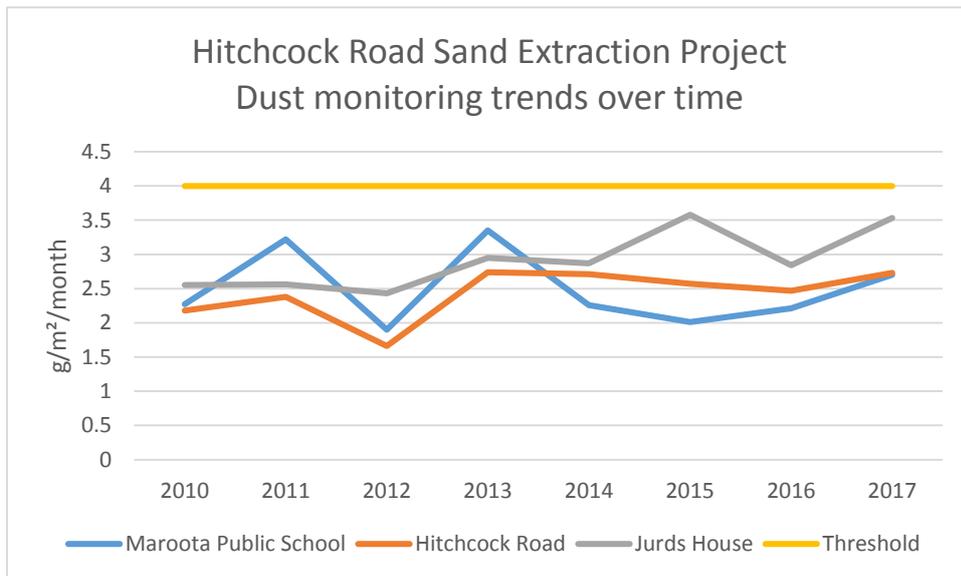
Chart 6. Dust monitoring trends over time – Insoluble Solids

- The insoluble solids portion of deposited dust is expected to be mineral matter with the ash content indicating the level of solid dust particles of inorganic origin such as soil/dust that could be derived from a source such as sand extraction and processing operations.
- The monitoring results are characterised by generally low average levels over extended periods with an occasional spike when high levels are experienced. As the operations from the site are

very consistent the dust generated from the site is consistent subject to weather impacts. Spikes are usually caused by factors unrelated to the quarry such as mowing or horticultural activities near the monitoring station or regional issues such as bush fires.

- The results of the dust deposit gauges were very good for the year being below the nuisance criterion. Because of the distances from the quarry operations and the significant other factors impacting the dust deposit gauge results high recordings are not necessarily a result of quarry operations. It is reassuring when all locations have relatively low results in the last few years.
