HITCHCOCK ROAD SAND EXTRACTION AND REHABILITATION PROJECT, MAROOTA

ANNUAL ENVIRONMENTAL MANAGEMENT REVIEW
2020 - 2021

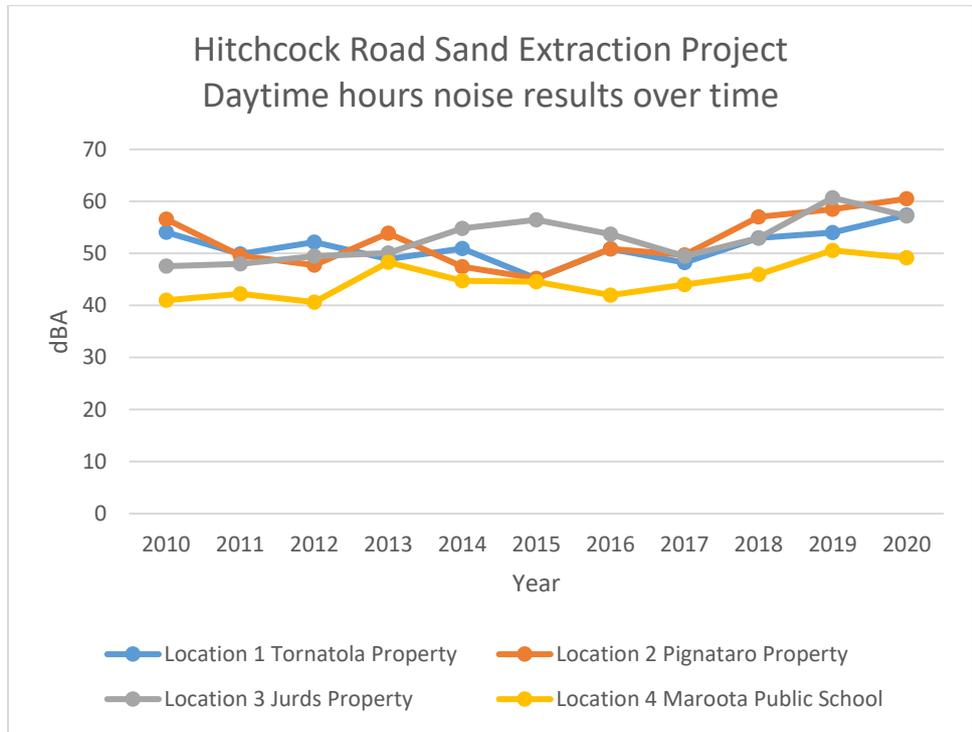
Chart 1. Daytime noise result trends over time

Koikas Acoustics concluded that noise results at all sites had been dominated by traffic or environmental noises during acoustic surveys over the past 12 month period and that quarry noise was either barely audible or inaudible. The site therefore complies with the nominated noise criteria.

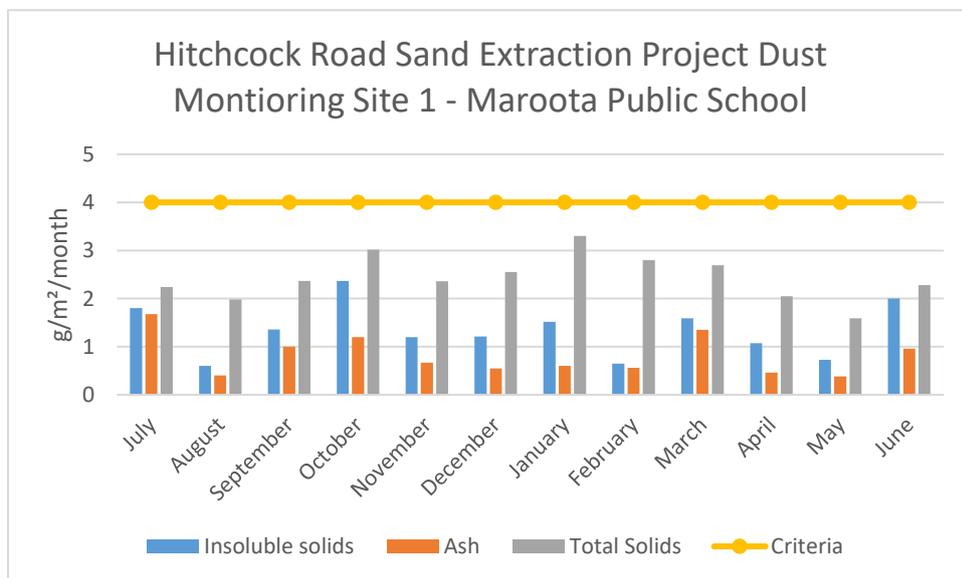
Chart 3. Dust monitoring results at Site 1 – Maroota Public School

- The insoluble solids portion of deposited dust is expected to be mineral matter with the ash content indicating the level of solid dust particles of inorganic origin such as soil/dust that could be derived from a source such as sand extraction and processing operations.
- The monitoring results are characterised by generally low average levels over extended periods with an occasional spike when high levels are experienced. As the operations from the site are very consistent, the dust generated from the site is consistent subject to weather impacts. Spikes are usually caused by factors unrelated to the quarry such as mowing or horticultural activities near the monitoring station or regional issues such as bush fires and dust storms.
- The spike in August is related to the Maroota Muster event held annually at the Maroota Public

School. Dry conditions with slashing/mowing of the adjacent paddock for heavy traffic flow on the day of the event almost always leads to a spike in total solids each reporting period. Although this event was not held during 2020 due to Covid 19 restrictions, the site was still prepared for the event with mowing and increased farm machinery usage in the immediate vicinity of the dust monitoring gauge. Results were compared with a neighbouring quarry (Dixon Sand) who also reported a spike in insoluble solids. The weather conditions recorded via the TEOM (owned by Dixon Sand) indicated that the event took place on a Sunday when no quarry activity was being undertaken.

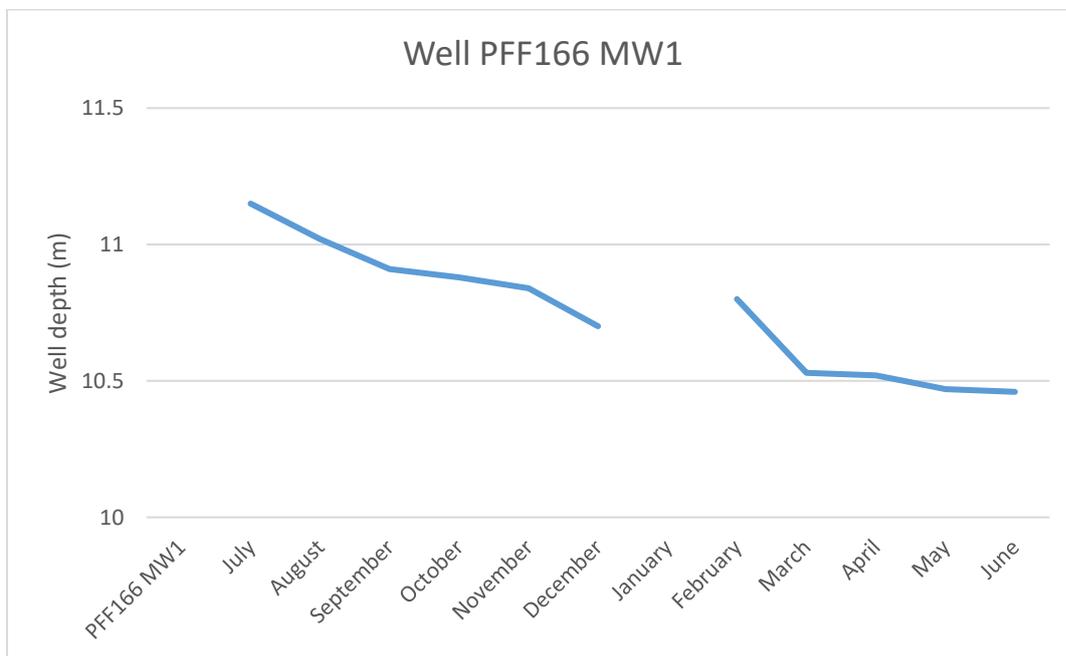
Chart 6. Ground water depth at monitoring bore 166MW1 (Access restricted during January)

The above average rainfall in the past 12 months has seen a steady increase in ground water depth at all deep water monitoring wells across the site. Water quality remained stable through the drought conditions from 2017-2020 with only two deep wells having a slight increase in EC and TDS . These wells have no stabilized with the return of regular rainfall events and the recharging of the ground water. All other test results have remained stable when compared to previous years.

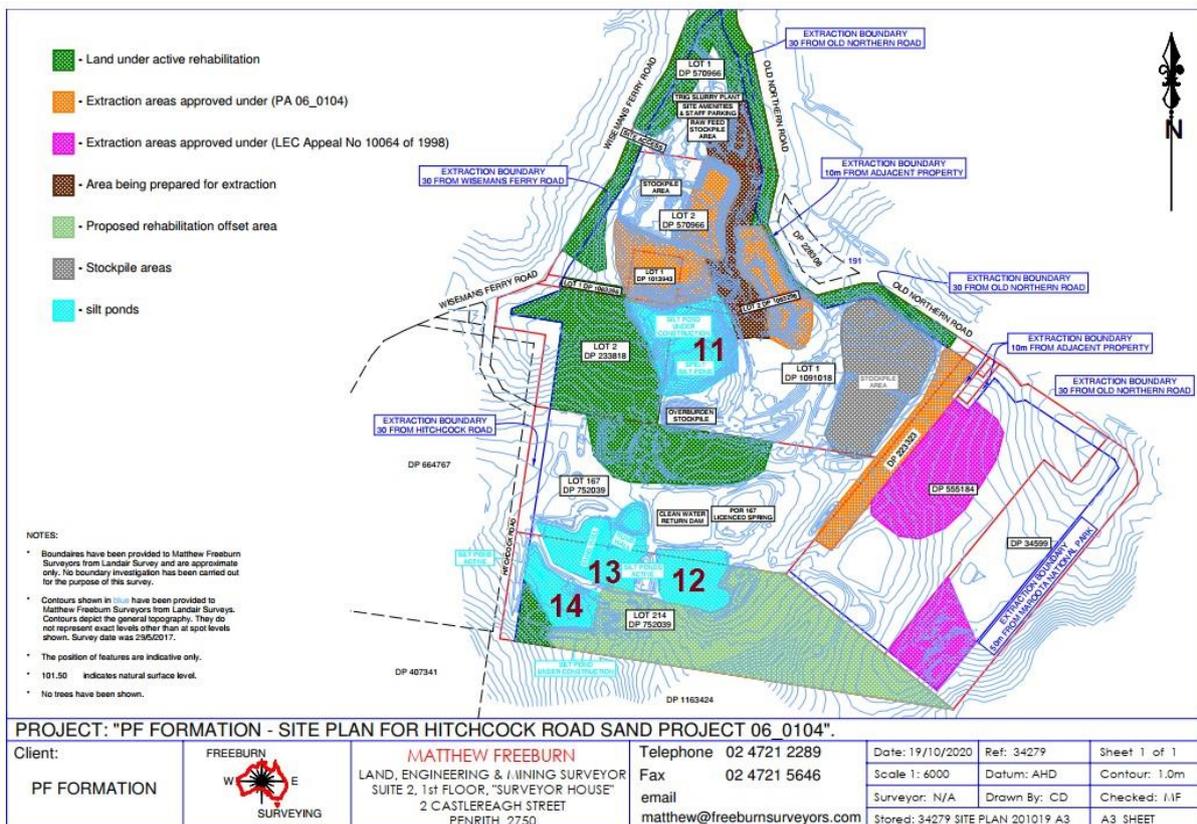
Figure 5. Location of numbered Silt ponds in tailings stream cycle.

All collected waters are reused in the processing cycle during the operational stage of the extraction works.
