HITCHCOCK ROAD SAND EXTRACTION AND REHABILITATION PROJECT, MAROOTA

Sand Extraction and Rehabilitation Project

ANNUAL REVIEW 2023-2024

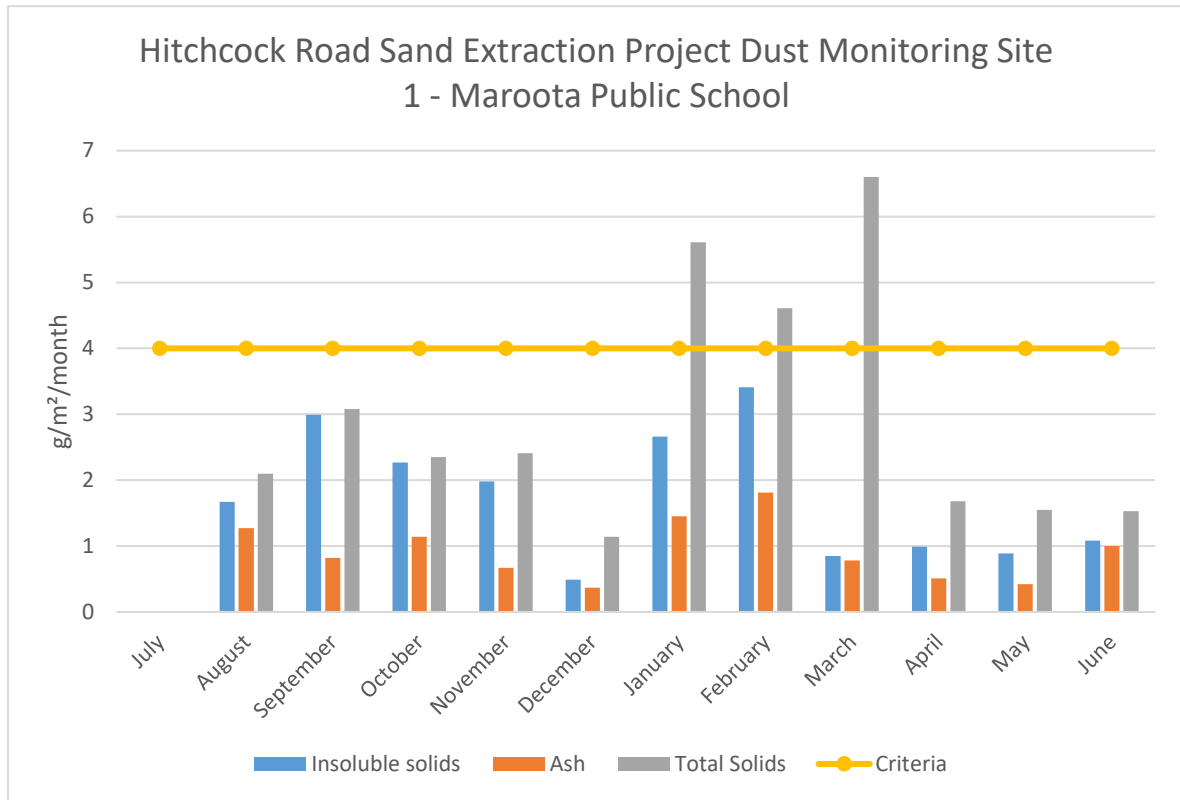
Chart 3. Dust monitoring results at Site 1 – Maroota Public School

- The monitoring results are characterised by generally low average levels over extended periods with an occasional spike when high levels are experienced. The operations from the site are very consistent with dust mitigation measures such as vehicular speed limits, watering the road regularly in dry weather and avoiding drop activities in high wind undertaken. Spikes in air quality results are usually caused by factors unrelated to the quarry such as mowing or horticultural activities near the monitoring station or regional issues such as bush fires and dust storms.

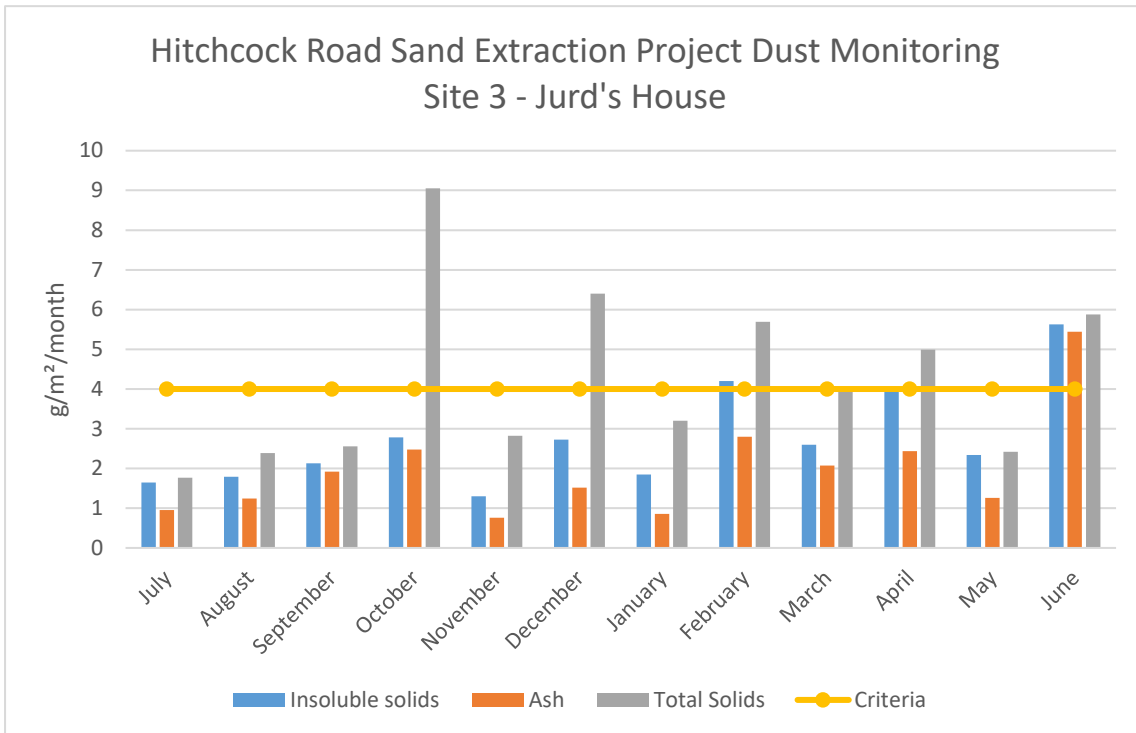
Chart 5. Dust monitoring results at Site 3 – Jurd’s House

- The spike in February and June 2024 at Jurds House is related to agricultural activities nearby where disc ploughing of a paddock had occurred. Wind speed during February or June 2024 did not exceed 14km/s throughout the month with the average speed being 1.3 and 0.7km/s as can be seen in Appendix 6. Wind direction did change throughout the month however due to all other ambient dust monitoring locations having consistently low results, this does indicate that the spike in insoluble solids at Jurds House was a localised event.

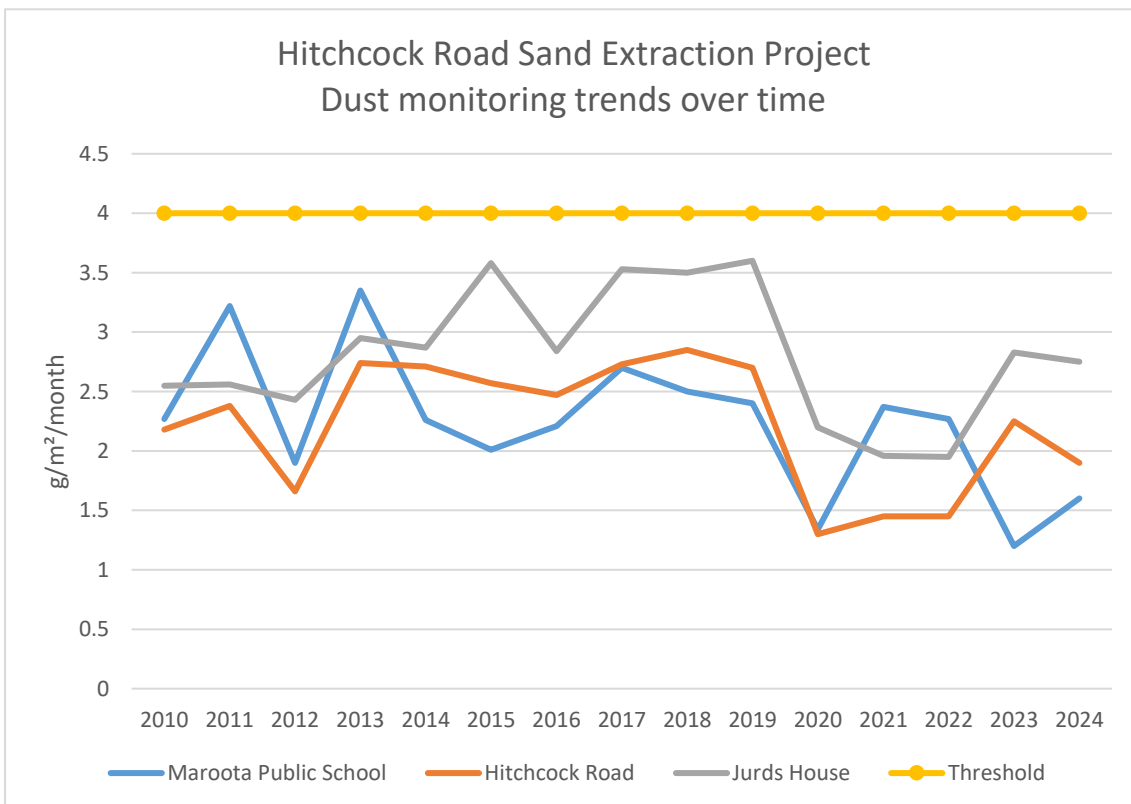
Chart 6. Dust monitoring trends over time – Insoluble Solids

- The insoluble solids portion of deposited dust is expected to be mineral matter with the ash content indicating the level of solid dust particles of inorganic origin such as soil/dust that could be derived from a source such as sand extraction and processing operations.

- The distances from the quarry operations and the significant other factors impacting the dust deposit gauge results, high recordings are not necessarily a result of quarry operations. It is reassuring when all locations have relatively low results in the last few years under normal environmental conditions.

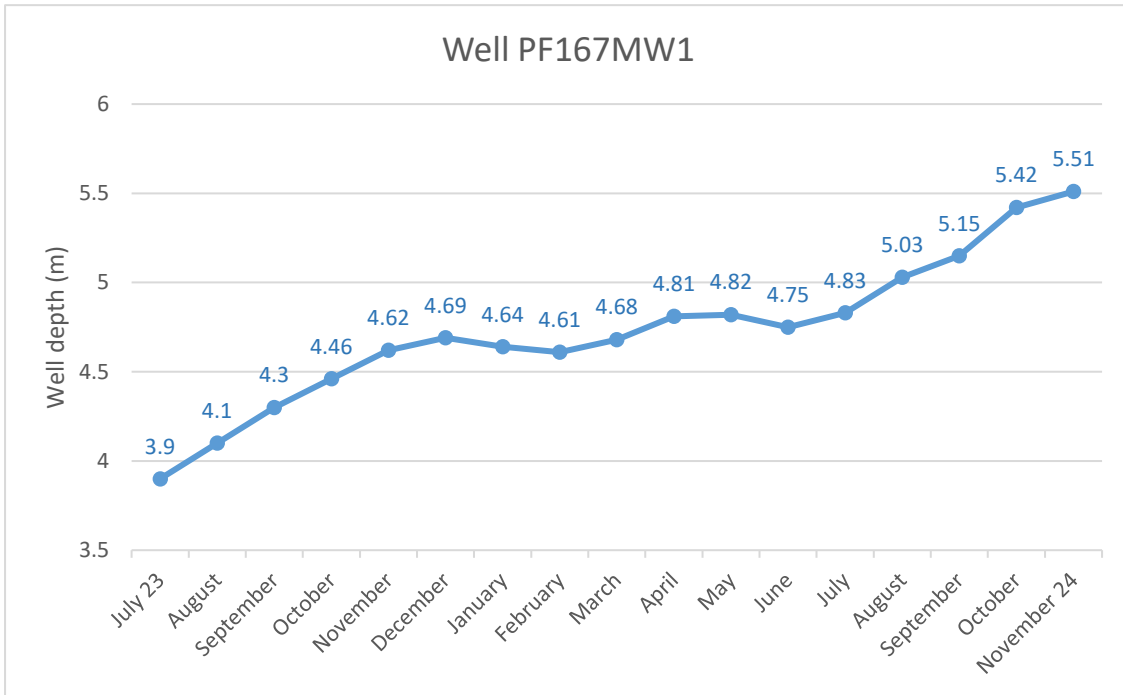
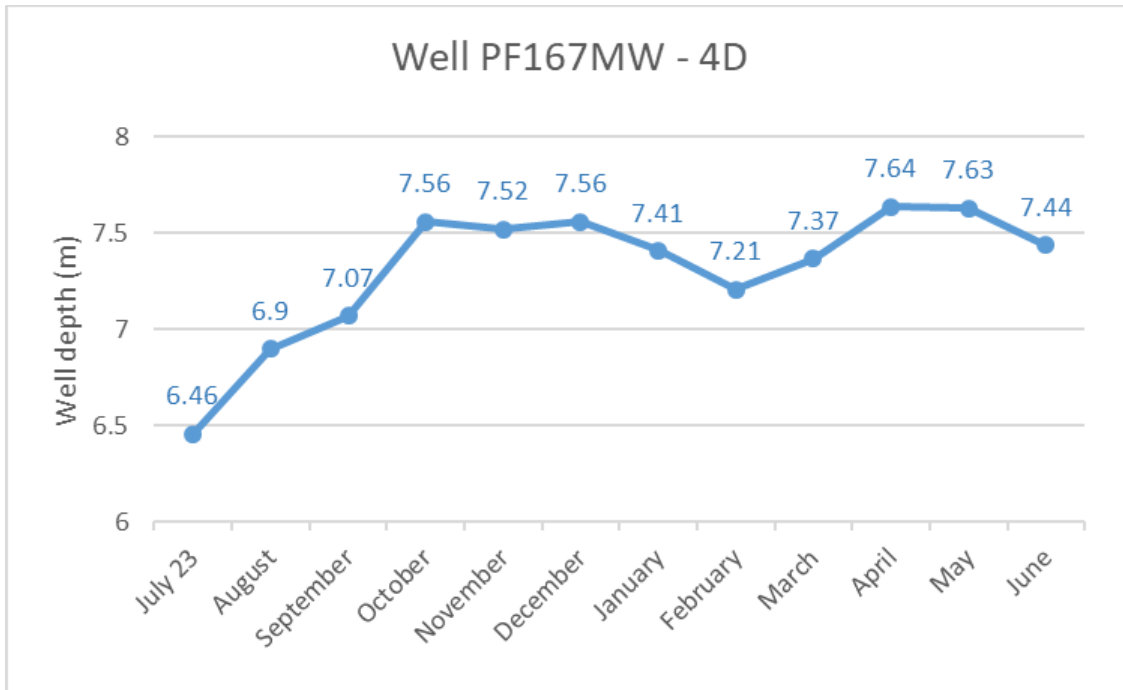
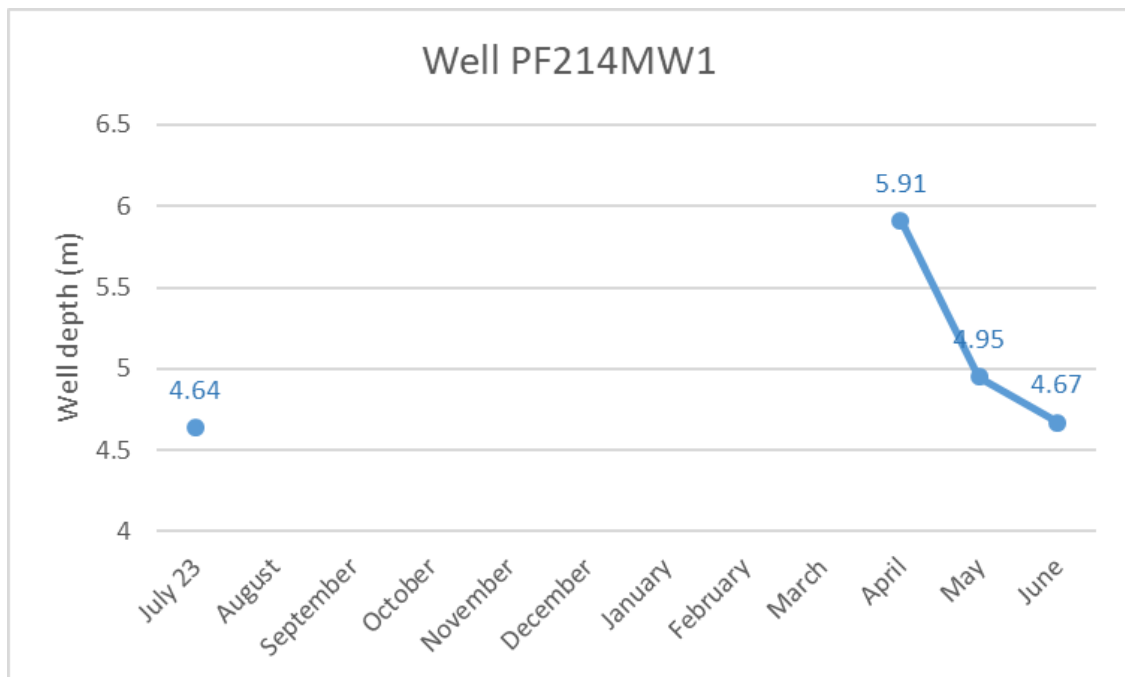
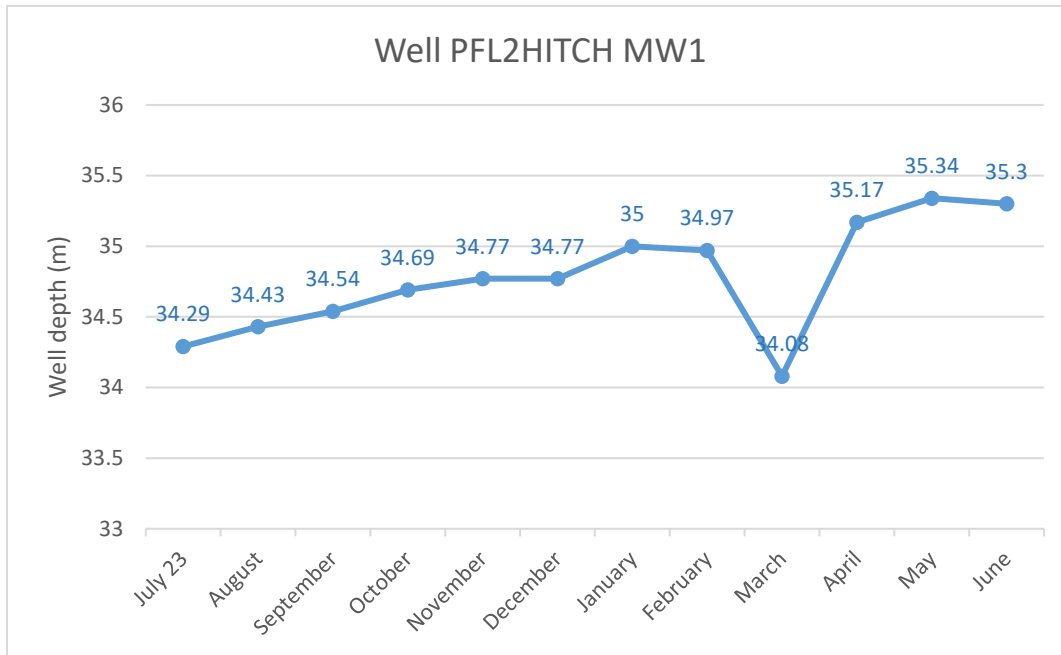
Rainfall returned to near average conditions during the reporting period following three years of above average rainfall which resulted in several 1 in 100 flood events occurring. The past 12 months has seen consistent levels in ground water depth at all deep water monitoring wells across the site. Water quality remained stable through the drought conditions from 2017-2020 with only two deep wells having a slight increase in EC and TDS. These wells have now stabilized with the return of regular rainfall events and the recharging of the ground water. All other test results have remained stable when compared to previous years.
